The Change Law and Application Research of Surrounding Rock Loose Circle Based on Visualization Test

Liang Chen

Chongqing Research Institute co.Ltd of China Coal Technology and Engineering Group Corporation, Chongqing 400037, China
 lelechen131452@163.com

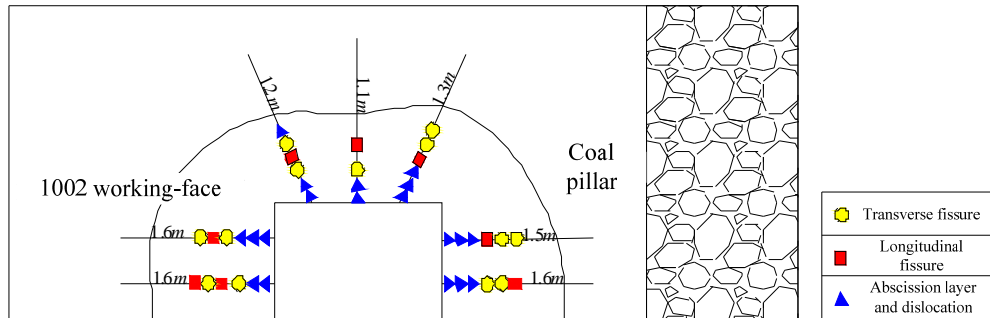
10-1# coal bed has placed all together two measure points, eight drill holes and eight constructions. Actually, seven drill holes are observed because of the equipment failure. As is seen from the observation results that the left surrounding rock is more complete, partial joint fissure develops incompletely and looseness range is not obvious. Drill hole shows that the maximum damage depth of the left coal body is 1.4 meter, and the exterior rock body is relatively complete. The area exists in this scope. The maximum damage depth is 1.6 meter, extending to near the hole edge. The tensile and shear failure mode are main mode of failure. Therefore, it is analyzed that the bolt length is not less than 1.6 meter and the anchorage zone must be 1.6 meter far from coal body. The right surrounding rock has a severe damage and a high degree of looseness

ranging from 0.38 to 1.6 meter. The looseness range should be not less than 1.6 meter. The right bolt length should be not less than 1.6 meter and the anchorage zone must be 1.6 meter far from coal body. Considering the coal body near the coal the coal pillar, it is suggested that the bolt length should be increased. The overall probe results show that the range of 10# loosen zone of coal bed is: tunnel roof is from 1.1 to 1.3 meter. The both sides are ranging from 1.5 to 1.6 meter. Therefore, the length should be not less than 1.7 meter. The right bolt length can be properly increased. The test results is shown in Figure 2.

Figure 2: The test results of loose circle at No.1 measure point in 10-1# coal seam

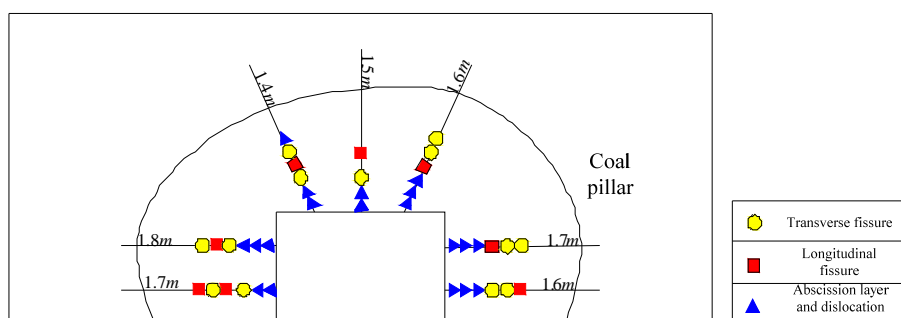
Figure 3: The test results of loose circle at No.1 measure points in 8# coal seam

The left surrounding rock is relatively cracked. Partial joint fissure develop completely. The range of looseness is relatively distinct. The shallow part mainly includes separation layer and misplacement. Partial vertical fracture can be seen in deep part. Drill holes show that the maximum damage depth of the left coal body is 1.8 meter, which extends to the area near the hole edge. Tensile and shear failure are main modes of failure. Therefore, it is analyzed that the length of the left rock bolt is at least 1.8 meter and the anchorage zone should lie in coal body 1.8 meter away. The right surrounding rock is damaged severely and has a great

degree of looseness ranging from 0.15 to 1.68 meter. The probe result shows that the coal body is relatively cracked and the exterior coal body is relatively complete ranging from 0.3 to 1.54 meter. Obviously, it is analyzed that the length of right rock bolt should be at least 1.7 meter and the anchorage range should lie in the coal body 1.7 meter away. According to the probe results, it is easy to find that the broken rock zone of 8# coal layer is: roof (1.4-1.6m), both sides (1.5-1.8m, 1.5-1.7m). Therefore, the length of mining roadway roof should be at least 1.6 meter, the length of left rock bolt should be more than 1.8 meter and the right rock bolt should be at least 1.7 meter. The test results is shown in Figure 3.
