# Fire Risk Assessment of Photovoltaic Plants. A Case Study Moving from two Large Fires: from Accident Investigation and Forensic Engineering to Fire Risk Assessment for Reconstruction and Permitting Purposes

Luca Fiorentini<sup>a\*</sup>, Luca Marmo<sup>b</sup>, Enrico Danzi, Vincenzo Puccia<sup>c</sup>

<sup>a</sup>Tecsa SRL, Via Figino 101, 20016 PEro (Milano), Italy

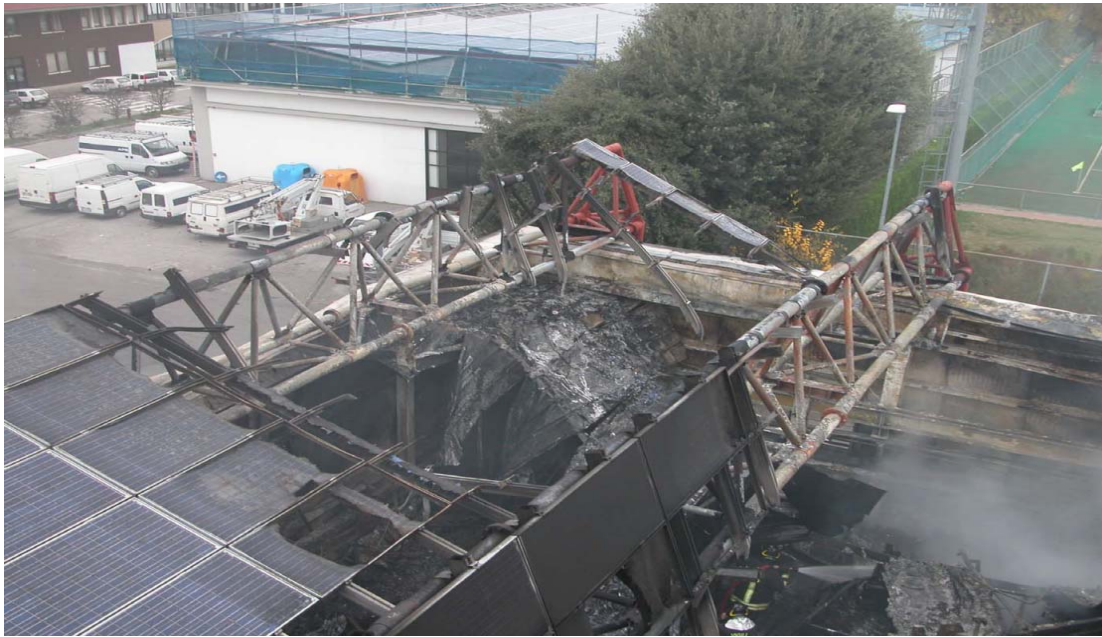
In Figure 2 a 1000 m<sup>2</sup> warehouse housing a PV plant keep on fire. The evidence of the fire investigation conducted evidenced various elements in charge of PV Plant. In that case a conventional PV plant was installed on a thermally insulated roof. The episode evidenced the lack on fire regulation related to the introduction of photovoltaic plants on existing roof coverings, designed and installed years earlier with the aim of a better thermal insulation by mean of thick combustible foam layers but potentially offering a tremendous fire load.

*Figure 2: a 1000 sq meters warehouse housing a PV plant keep on fire. The evidence of the fire investigation conducted reported various elements in charge of PV Plant.*

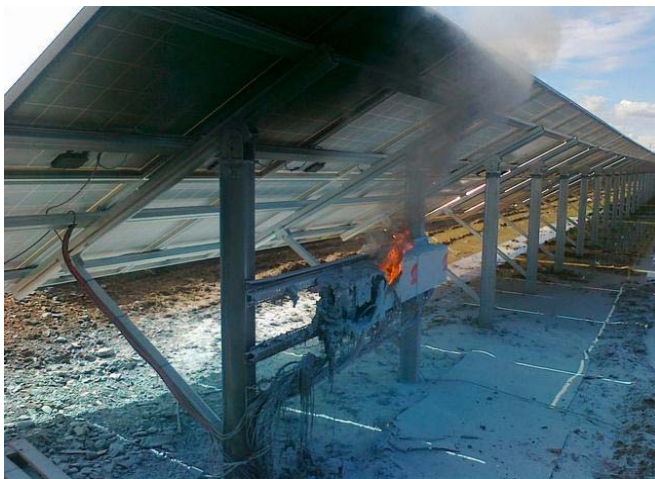
The typologies of fires resulted in various magnitudes from a small fire ignited in an electric box (Fig. 3) to the complete ignition of the cover, spreading the fire inside the compartment with a top down pattern, until now uncommon (nearly unknown) in the fire investigation literature.

*Figure 3: the Fire of a Connection Box in a ground PV Plant.*

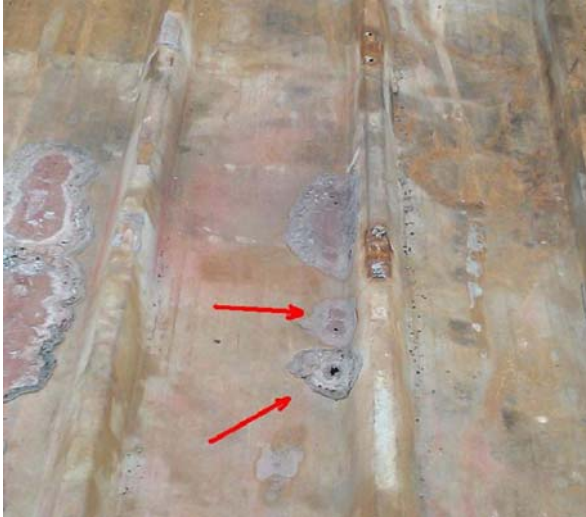
Figure 4: the The DC arcing effects on a external side of a polyurethane sandwich.

The incorrect installation, or simply a fault in a component, could easily ignite a severe DC arcing, with a stable current flow enough intense to drill a metal layer of a sandwich, and consequently ignite the combustible layer below it.

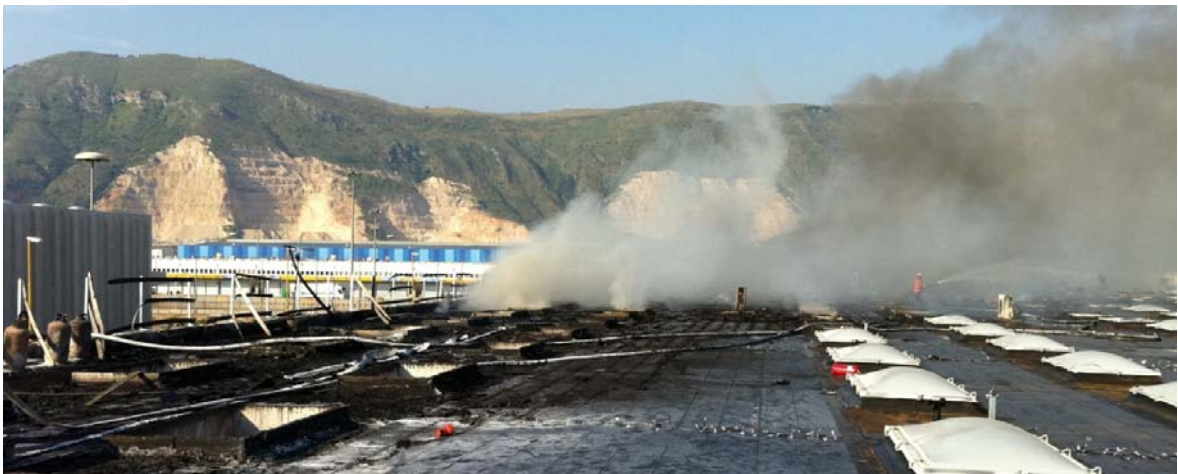
Also non-conventional PV plant adopting the in-roof technology were involved in fires of, in some circumstance, large magnitude. This is the case of the fire of a 6000 m<sup>2</sup> roof plant depicted in Figure 5. The resulting fire produced large plumes spreading on city skyline, which produced citizen concern on environmental pollution and public safety.

Figure 5: A large warehouse involved by a fire, probably external at the PV plant but strongly influenced in his growth and propagation by the photovoltaic layers.

As the case depicted in Figure 5 concerns, a preventive fire risk assessment on the photovoltaic roof configuration should have early identified the inherent fire hazard produced by coupling a strong fire load to a new ignition source (i.e. the fire load inside the compartment and the in-roof installation of PV panels).
