Failure of cargo aileron's actuator

ABSTRACT. During a ferry flight, in a standard operation condition and at cruising level, a military cargo experienced a double hydraulic system failure due to a structural damage of the dual booster actuator. The booster actuator is the main component in mechanism of aileron's deflection. The crew was able to arrange an emergency landing thanks to the spare oil onboard: load specialists refilled the hydraulic reservoirs. Due to safety concerns and in order to prevent the possibility of other similar incidents, a technical investigation took place. The study aimed to carry out the analysis of root causes of the actuator failure. The Booster actuator is composed mainly by the piston rod and its aluminum external case (AA7049). The assembly has two bronze caps on both ends. These are fixed in position by means of two retainers. At one end of the actuator case is placed a trunnion: a cylindrical protrusion used as a pivoting point on the aircraft. The fracture was located at one end of the case, on the trunnion side, in correspondence to the cap and over the retainer. One of the two fracture surfaces was found separated to the case and with the cap

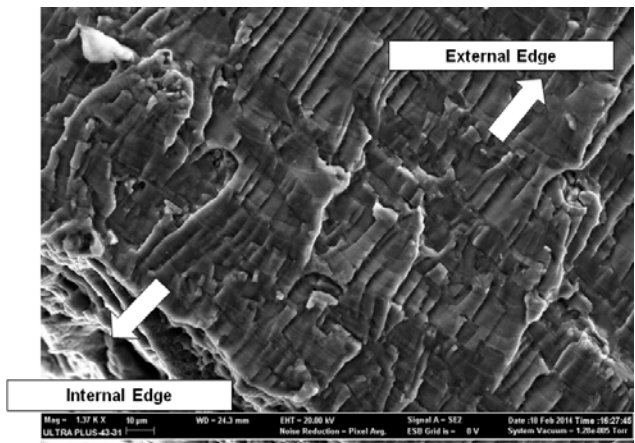
FESEM observations of the Zone B of fracture surface confirmed the presence of the fatigue crack mechanism Fig. 6 and Fig. 7. Multiple initiation sites of the fatigue crack are all around the external edge of the fracture surface. Zone A showed dimples and microvoid, these are evidences of unstable fatigue crack propagation (Fig. 8) [1].

Figure 6: Area of fatigue crack propagation.

Figure 7: Area of fatigue crack propagation.

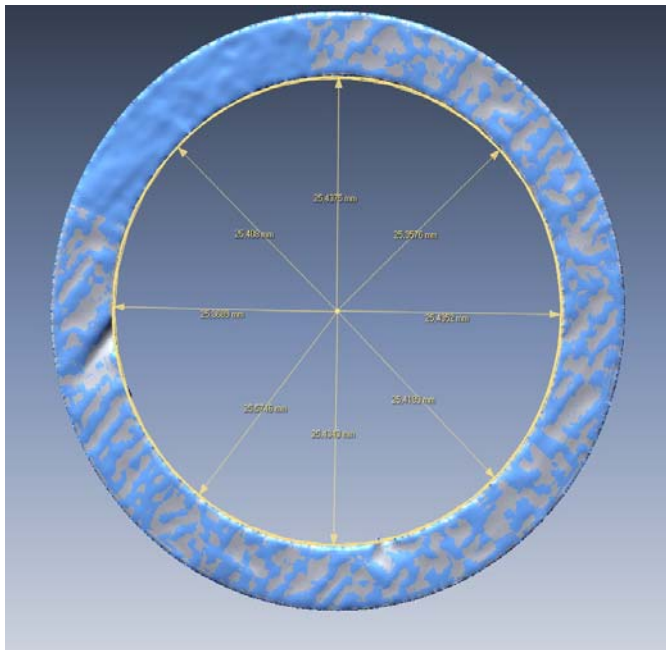
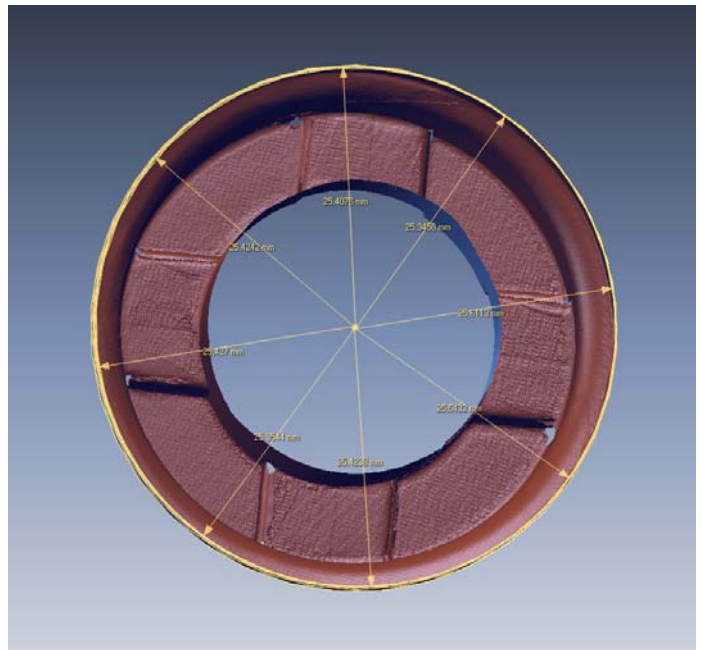
Figure 12: Actuator Case internal diameter measurements.

Figure 13: Cap external diameter measurements.

The two parts have an average mechanical interference of 25 μm . This was the reason of the tight fit observed during disassembly operations between external case and cap.

Therefore, the required gap should be comprised between 25.4 to 101.6 μm .

The Dual Booster Actuator failed because of a high-cycle multiple initiation sites fatigue mechanism. This was due to stress intensification caused by dimensional non conformances. Recommendations were issued in order to improve dimensional controls.

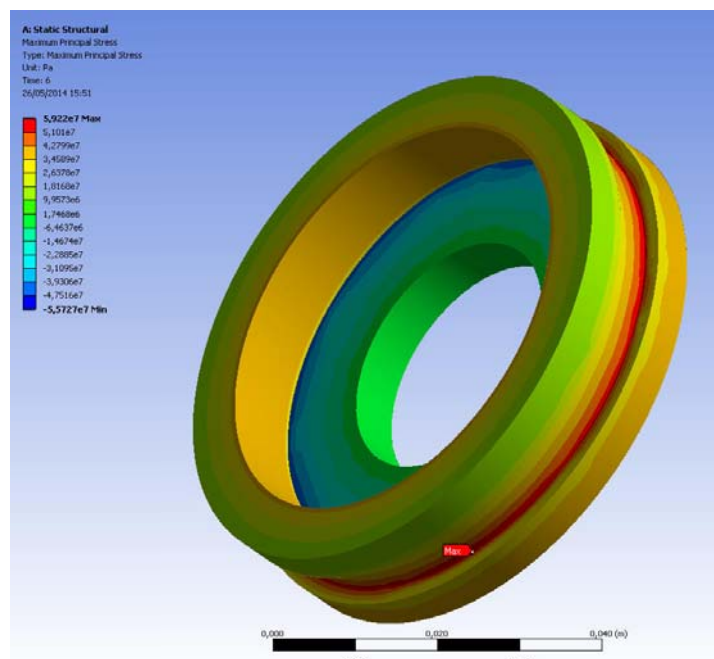
Numerical results showed how just the perfect fit was enough to increase the stress value of about 60 MPa. In the real condition of forced coupling (about 25 μm interference) the stress increase would be higher. Stress map Fig. 16 shows how the maximum stress is reached on the outer edge of the case Assy. A parametrical simulation was carried out increasing the gap between the actuator case and the cap. Results showed that the stress became null at about 50 μm of gap (Fig. 17).

Figure 16: Stress Map.
