Multiaxial fatigue of in-service aluminium longerons for helicopter rotor-blades

ABSTRACT. Fatigue cracking of longerons manufactured from Al-alloy AVT-1 for helicopter in-service rotor-blades was considered and crack growth period and equivalent of tensile stress for different blade sections were estimated. Complicated case of in-service blades multiaxial cyclically bending-rotating and tension can be considered based on introduced earlier master curve constructed for aluminum alloys in the simple case of uniaxial tension with stress R-ratio near to zero. Calculated equivalent tensile stress was compared for different blade sections and it was shown that in-service blades experienced not principle difference in this value in the crack growth direction by the investigated sections. It is not above the designed equivalent stress level. Crack growth period estimation in longerons based on fatigue striation spacing or meso-beach-marks measurements has shown that monitoring system introduced designer in longerons can be effectively used for in-time crack detecting independently on the failed section when can appeared because of various type of material faults or in-service damages.

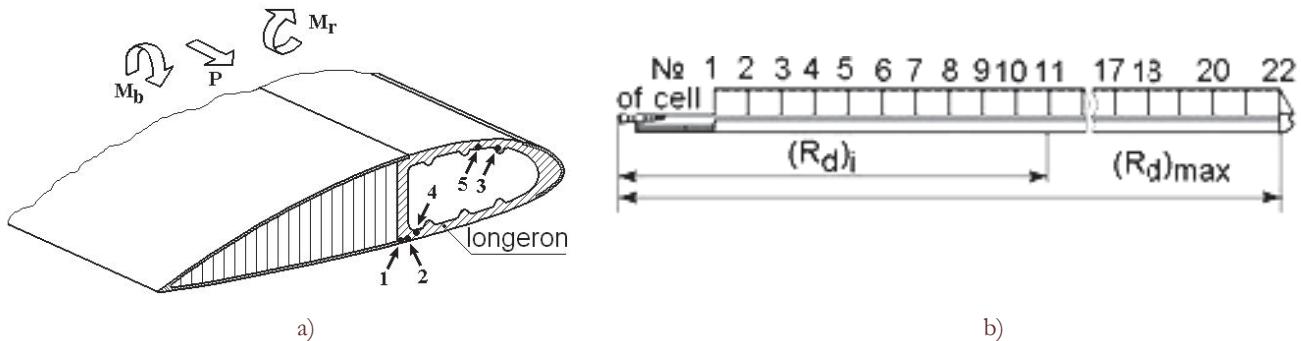
Figure 1: Scheme (a) of rotor-blade section with numbering “1”-“5” areas for crack origination and pointed out its external loading and (b) cells position for a blade.

In-service fatigue cracks nucleated in the longerons in the defect sites that were revealed all over the blade length, from $\bar{R} = 0.085$ to $\bar{R} = 0.71$, where $\bar{R} = (R_d)_i / (R_d)_{\max}$ (see Fig. 1b).

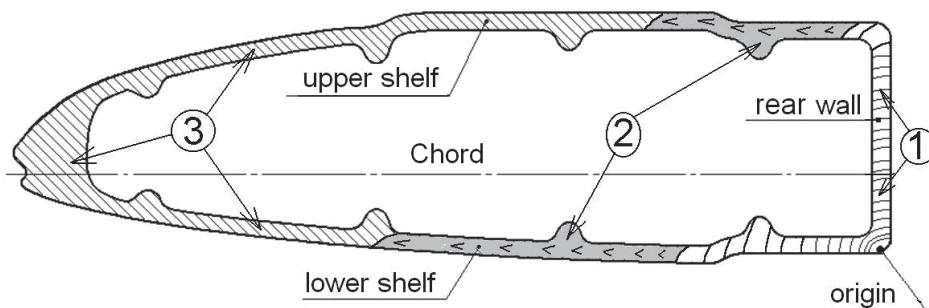
- a fracture-origin exhibits a fracture relief typical of the damage kind and may be located anywhere on the inner or outer surface of the longeron walls;
- a zone (1) of stable crack growth typically exhibits a smooth fracture surface with distinct mesoscopic or macroscopic (depending of the fracture location) beach-marks of fatigue fracture;
- a zone (2) of accelerated crack propagation typically shows a wavy fracture surface of the “Christmas-tree” or “chevron-like” type;

Figure 2: Scheme of longerons fracture surfaces for crack origination from the corrosion pitting with indication “1”-“3” different fracture surface areas.

- a zone (3) of fast crack propagation when the plastic-shear lips form entirely over the wall-thickness of the longeron. In the zone 1, pseudo-striations pattern forms first (P-region), peculiar to low-rate crack growth in the near-threshold range of the kinetic diagram. The material here experiences extensive shear. As the crack length increases, a pattern of fatigue striations forms or, alternatively, mesoscopic fatigue beach-marks dominate, depending on the blade section in that the crack propagates.

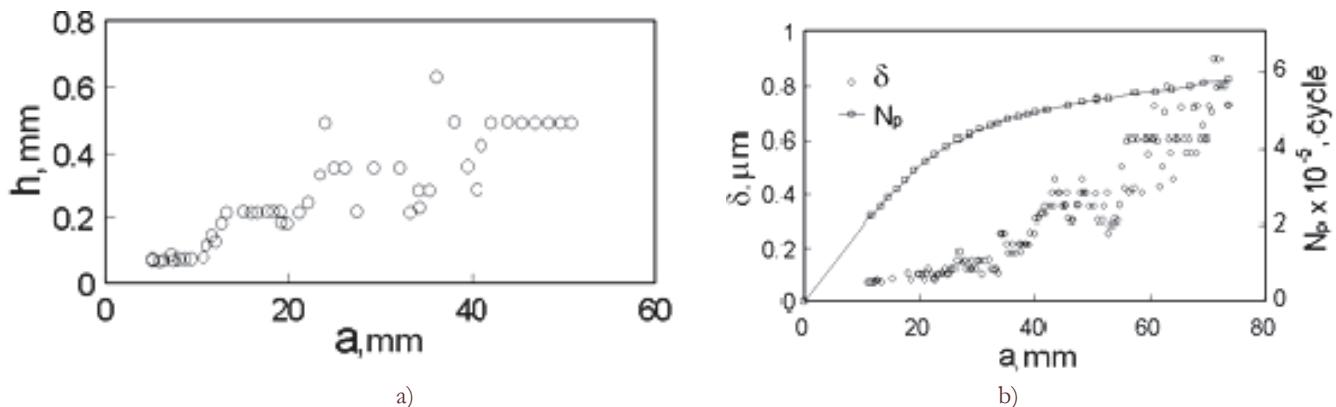
Sequentially measured distances between MBM and, then, between the Macro-Beach-Marks confirmed that there recurrence along the crack path is not casual, but regular, indicative of the very blade-loading patterns, regularly repeated with each single flight cycle, Fig. 3. Therefore, the regularly increasing distances between these marks are indicative of the crack-growth rate regularly increasing from flight to flight. And the number of these beach-marks corresponds to the number of the helicopter flights accomplished with the fatigue crack propagating in the longeron.

Figure 3: Spacing of (a) meso- or macro-beach-marks and (b) fatigue striations with number of cycles N_p against crack length a for two longerons (a) and (b).
