Multiaxial fatigue of in-service aluminium longerons for helicopter rotor-blades

ABSTRACT. Fatigue cracking of longerons manufactured from Al-alloy AVT-1 for helicopter in-service rotor-blades was considered and crack growth period and equivalent of tensile stress for different blade sections were estimated. Complicated case of in-service blades multiaxial cyclically bending-rotating and tension can be considered based on introduced earlier master curve constructed for aluminum alloys in the simple case of uniaxial tension with stress R-ratio near to zero. Calculated equivalent tensile stress was compared for different blade sections and it was shown that in-service blades experienced not principle difference in this value in the crack growth direction by the investigated sections. It is not above the designed equivalent stress level. Crack growth period estimation in longerons based on fatigue striation spacing or meso-beach-marks measurements has shown that monitoring system introduced designer in longerons can be effectively used for in-time crack detecting independently on the failed section when can appeared because of various type of material faults or in-service damages.

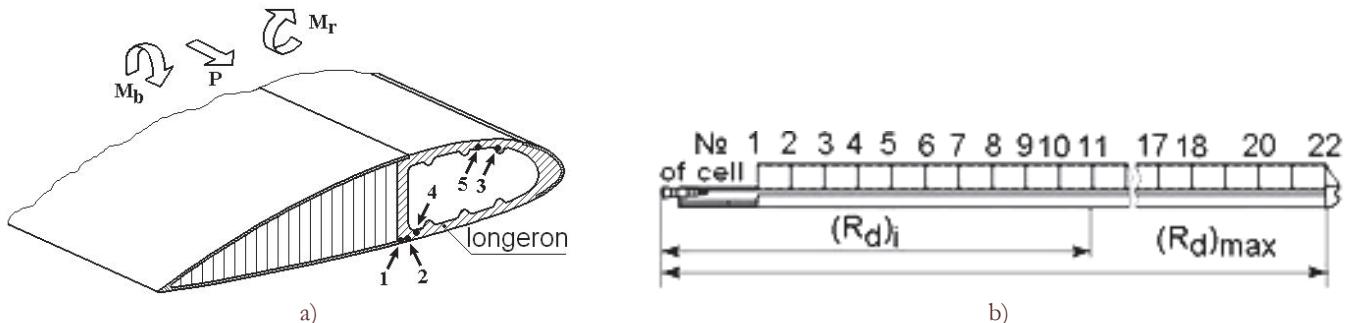
Figure 1: Scheme (a) of rotor-blade section with numbering “1”-“5” areas for crack origination and pointed out its external loading and (b) cells position for a blade.

In-service fatigue cracks nucleated in the longerons in the defect sites that were revealed all over the blade length, from $\bar{R} = 0.085$ to $\bar{R} = 0.71$, where $\bar{R} = (R_d)_i / (R_d)_{\max}$ (see Fig. 1b).

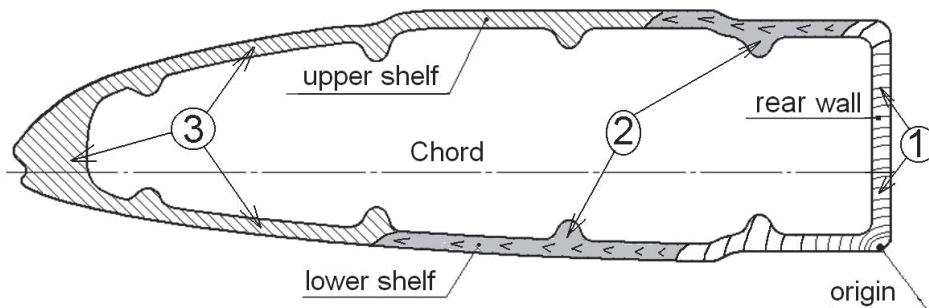
- a fracture-origin exhibits a fracture relief typical of the damage kind and may be located anywhere on the inner or outer surface of the longeron walls;
- a zone (1) of stable crack growth typically exhibits a smooth fracture surface with distinct mesoscopic or macroscopic (depending of the fracture location) beach-marks of fatigue fracture;
- a zone (2) of accelerated crack propagation typically shows a wavy fracture surface of the “Christmas-tree” or “chevron-like” type;
- a zone (3) of fast crack propagation when the plastic-shear lips form entirely over the wall-thickness of the longeron.

In the zone 1, pseudo-striations pattern forms first (P-region), peculiar to low-rate crack growth in the near-threshold range of the kinetic diagram. The material here experiences extensive shear. As the crack length increases, a pattern of fatigue striations forms or, alternatively, mesoscopic fatigue beach-marks dominate, depending on the blade section in that the crack propagates.

Formation of fatigue striations alternating with dimpled fracture is typical of the zone 2: here, the crack growth becomes accelerated.

Purely dimpled relief is typical of the zone 3 of final fracture; here the plastic-shear lips form throughout an entire thickness of the blade wall.

Figure 2: Scheme of longerons fracture surfaces for crack origination from the corrosion pitting with indication “1”-“3” different fracture surface areas.

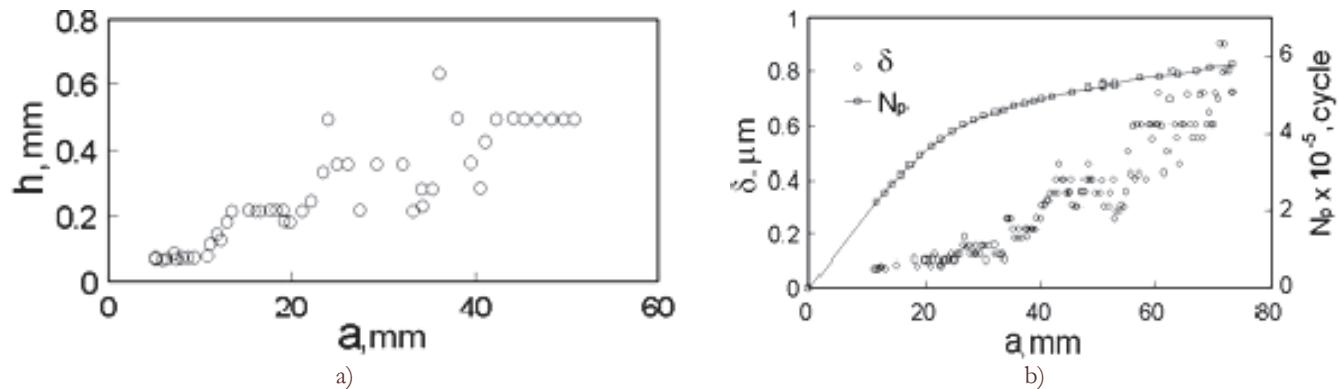
Figure 3: Spacing of (a) meso- or macro-beach-marks and (b) fatigue striations with number of cycles N_p against crack length a for two longerons (a) and (b).

Fatigue MBM were counted starting from the area 5.5 mm apart from the crack-origin site (the lines became most distinct here) to find out that the following crack-growth period involved about 210 flights. The inter-MBM distances (and, hence, the crack-length increments) appeared to sequentially increase. For the crack length grown from 5.5 to 7 mm, the average length increment did not exceed 0.056 mm per flight. So, not less than 70 flights were done with the fatigue crack growing in length from 1.5 to 5.5 mm. The starting crack length of 1.5 mm was taken a little greater than the depth (1.3 mm) of the stress-corrosion-origin. In total, these estimations give 280 (210 + 70) flight cycles for the period of crack propagation from the corrosion-cracking zone till the beginning point of unstable fracture.
