## Further investigation on microstructure refinement of internal crack initiation region in VHCF regime of high-strength steels

**ABSTRACT.** The profile samples prepared by focused ion beam (FIB) in crack initiation region (CIR) and fish-eye (FiE) region of failed specimens subjected to rotary bending (RB) and ultrasonic axial (UL) fatigue testing with various stress ratios ( $R$ ) were observed by transmission electron microscopy (TEM) with selected area electron diffraction (SAD) detection for two high-strength steels. The grain size and the thickness of nanograin layer along the crack growth path in CIR underneath fine-granular-area (FGA) were measured for the cases of  $R < 0$ , and a normalized quantity  $d^*$  based on the detected SAD patterns was introduced to quantitatively demonstrate the variation of the grain size. The results showed that the nanograin size near the origin (an inclusion) of crack initiation is smaller than that away from the inclusion. Nevertheless, there was no evidence of grain refinement in CIR for the cases of  $R > 0$  and the FiE region outside CIR for either negative or positive stress ratio cases, which suggests that the formation of nanograi

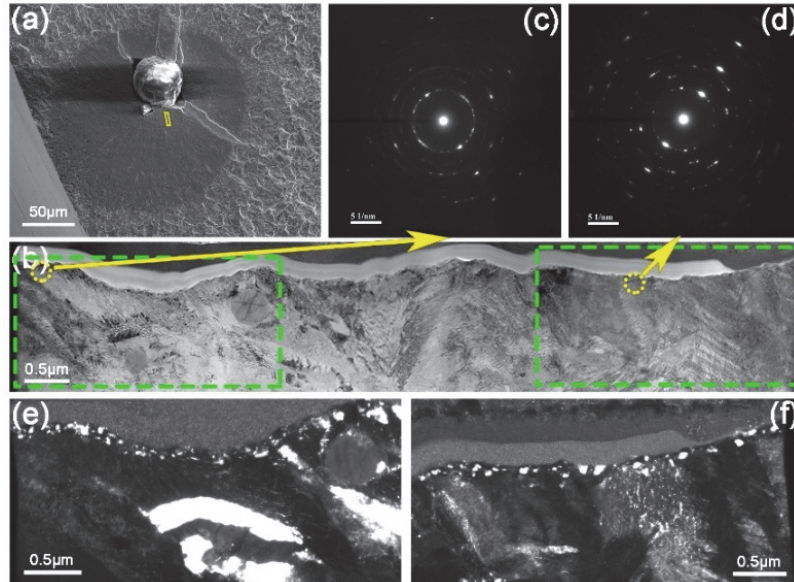
It can be seen from Tab. 2 that A1, B1 and B2 samples were cut from CIR of the failed specimens bearing fatigue loading with negative stress ratios in VHCF regime. Fig. 1 illustrates the microstructural features of sample A1. It is seen from Fig. 1a that the crack initiated from a spherical inclusion then to form an FGA region. The small dashed yellow rectangle in Fig. 1a represents the sampling location in the FGA region, and Fig. 1b illustrates the bright field imaging (BFI) of sample A1. Figs. 1c and 1d show the SAD patterns at the locations just underneath the FGA surface with discontinuous diffraction rings of polycrystals, which suggests that there are several grains within the diffraction area of 200 nm in diameter. Figs. 1e and 1f are dark field images (DFI) of the left and right dashed green boxes marked in Fig. 1b, and the fine granular layer can be clearly observed in both figures.

Figure 1: Microstructural features of sample A1 (RB,  $R = -1$ ,  $\sigma_a = 775$  MPa,  $N_f = 2.40 \times 10^7$ ), (a) SEM image of CIR showing the sampling location by a marked dashed yellow rectangle; (b) BFI; (c,d) SAD patterns of the left and right dashed yellow circles in (b); (e,f) DFI of the left and right dashed green boxes in (b).

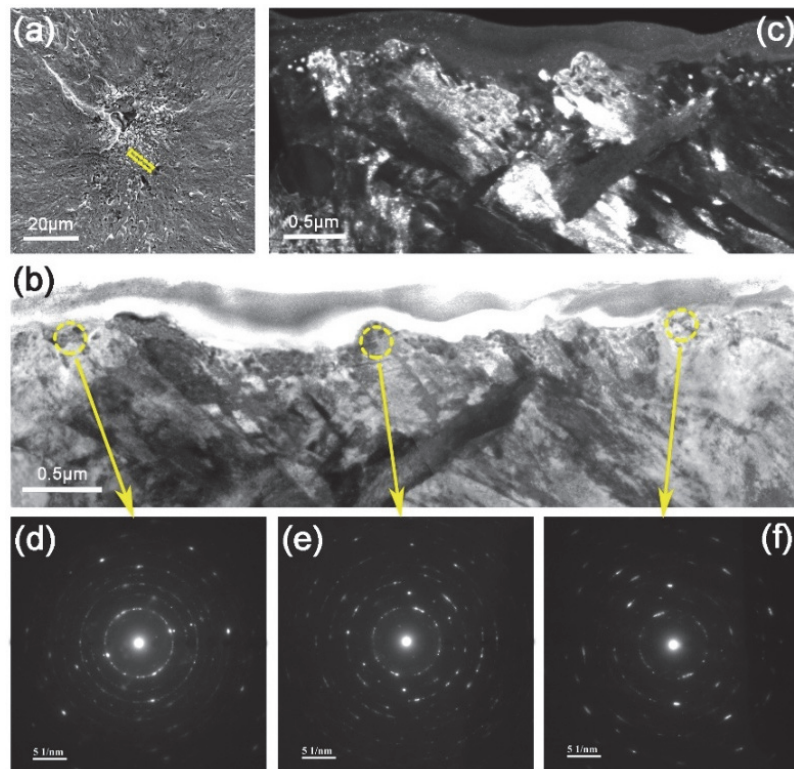
Fig. 2 illustrates the microstructural features of sample B1. Similar to the above situation of sample A1, in the failed specimen associated with sample B1, the crack also originated from an inclusion to form an FGA region. BFI and DFI of the sample, displayed as a small dashed yellow rectangle in Fig. 2a, are presented in Figs. 2b and 2c, respectively. Both BFI

and DFI showed that there are many fine grains near the fracture surface. SAD patterns of the left, middle and right dashed yellow circles marked in Fig. 2b are illustrated in Figs. 2d-f. All of these three patterns are discontinuous diffraction circles, suggesting several grains existing at these different locations. Similar results were obtained for sample B2 (as shown in Fig. 3).

Figure 2: Microstructural features of sample B1 (UL,  $R = -1$ ,  $\sigma_a = 989$  MPa,  $N_f = 1.11 \times 10^8$ ), (a) Origin of crack initiation showing clear FGA feature; (b) BFI; (c) DFI; (d-f) SAD patterns of the left, middle and right dashed yellow circles in (b).

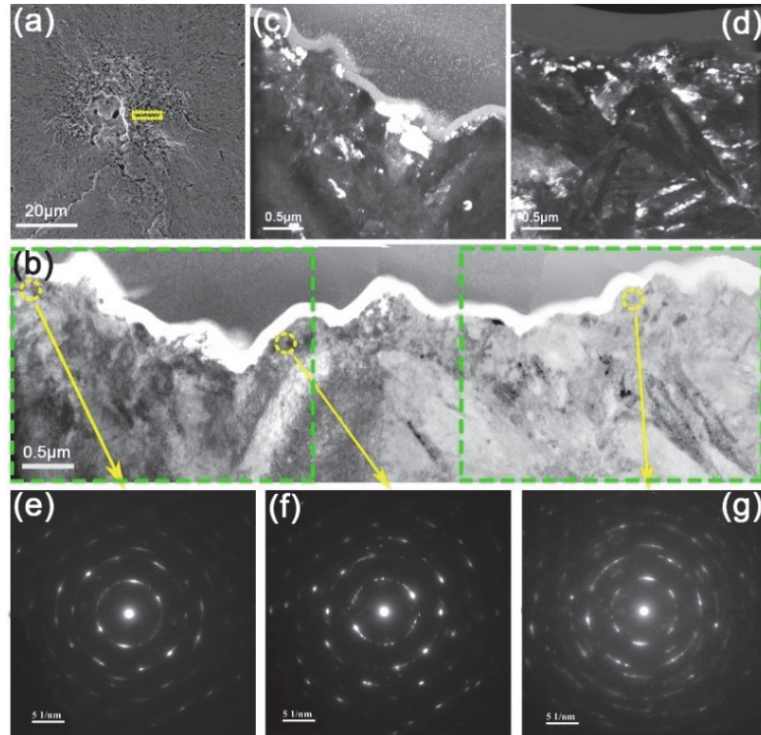
Figure 3: Microstructural features of sample B2 (UL,  $R = -0.5$ ,  $\sigma_a = 633$  MPa,  $N_f = 4.81 \times 10^8$ ), (a) SEM image showing crack origin; (b) BFI; (c,d) DFI of the left and right dashed green boxes in (b); (e-g) SAD patterns of the left, middle and right dashed yellow circles in (b).

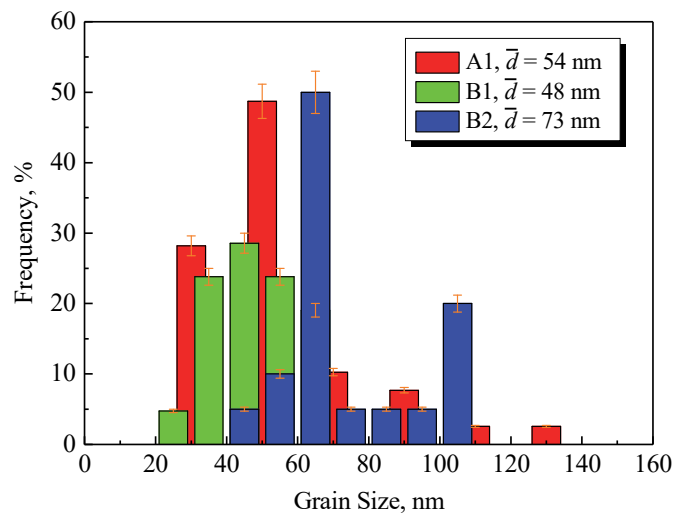
Figure 4: Distribution of grain size underneath FGA surface for samples A1, B1 and B2.

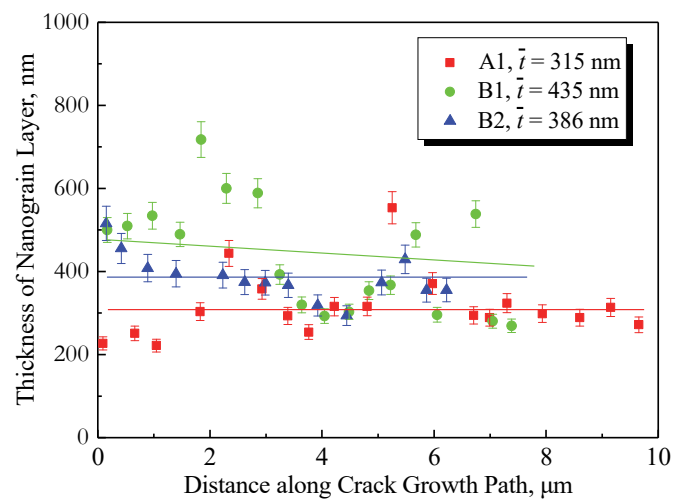
Figure 5: Thickness of nanograin layer along crack growth path underneath FGA surface for samples A1, B1 and B2.

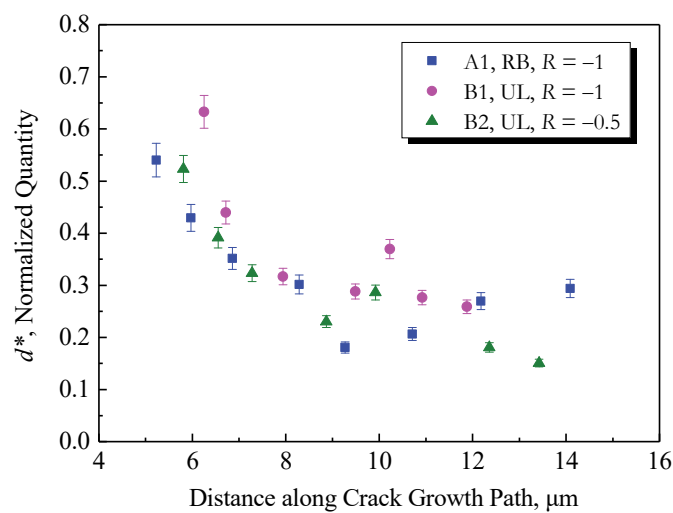
For this purpose, a number of discontinuous diffraction rings associated with  $\{110\}$  planes for samples A1, B1 and B2 were measured, and the results described by  $d^*$  are illustrated in Fig. 6. The value of  $d^*$  notably decreases along the crack growth path, implying that the size of nanograins gradually increases with the propagation of the crack, which may be due to gradually-reduced pressing actions. Moreover, the datum points of B1 are evidently higher than those of A1 and B2, suggesting that the greater compressive stress and the longer loading cycles may promote the grain refinement.

Figure 6: Distribution of normalized quantity  $d^*$  versus crack growth path for samples A1, B1 and B2.

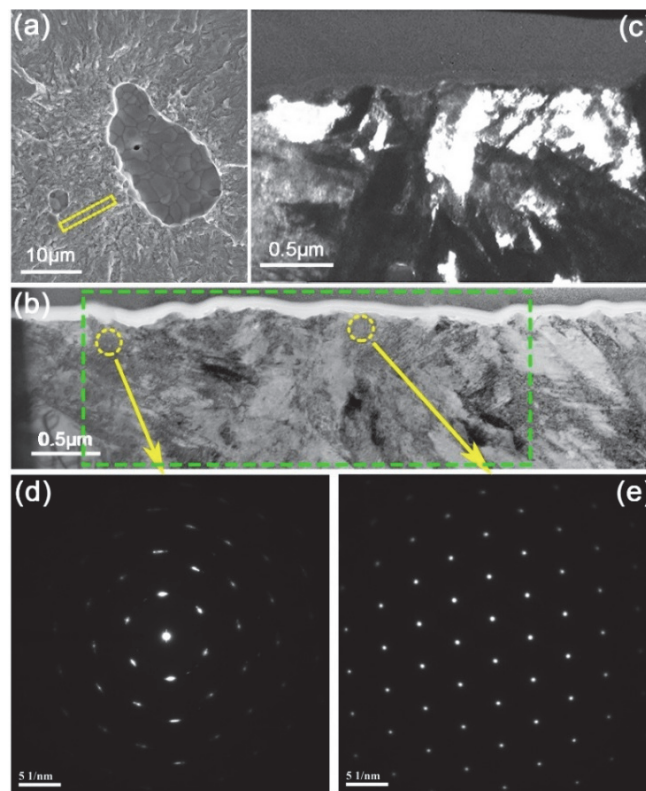
Fig. 7 illustrates the microstructural features of sample B3 ( $R = 0.1$ ), and the sampling location is denoted by a small dashed yellow rectangle shown in Fig. 7a, from which a cluster of inclusions as the origin of crack initiation and the diminishing FGA feature can be clearly observed. Fig. 7b presents the whole BFI of sample B3, and the DFI of its local location (dashed green box) is illustrated in Fig. 7c, showing that any position on the profile is original martensite microstructure, meaning no sign of grain refinement. Fig. 7d shows the SAD pattern of slightly elongated diffraction spots, which is the result of localized plastic deformation. Fig. 7e shows the SAD pattern with typical isolated spots, which are the normal diffraction of a single crystal, i.e., the original coarse martensite microstructure. Similar observations of sample B4 ( $R = 0.3$ ) are obtained as shown in Fig. 8.

Figure 7: Microstructural features of sample B3 (UL,  $R = 0.1$ ,  $\sigma_a = 534$  MPa,  $N_f = 1.84 \times 10^7$ ), (a) SEM image showing crack origin; (b) BFI; (c) DFI of the dashed green box in (b); (d,e) SAD patterns of the left and right dashed yellow circles in (b).

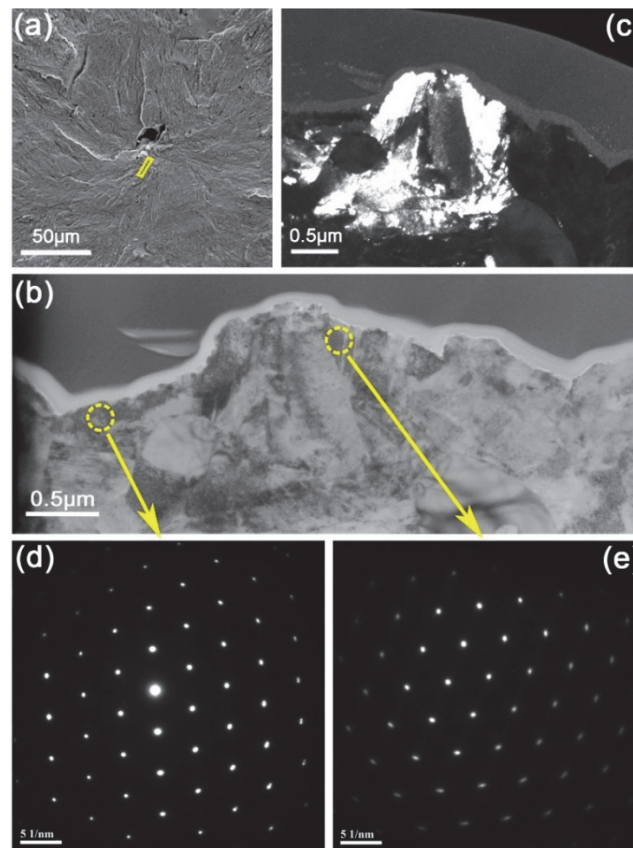
Figure 8: Microstructural features of sample B4 (UL,  $R = 0.3$ ,  $\sigma_a = 989$  MPa,  $N_f = 8.70 \times 10^8$ ), (a) SEM image showing crack origin; (b) BFI; (c) DFI; (d,e) SAD patterns of the left and right dashed yellow circles in (b).

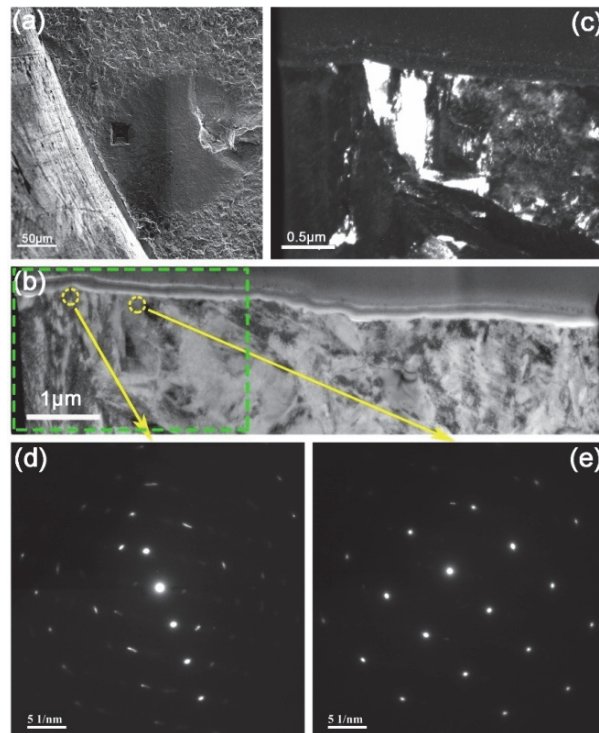
Fig. 9 illustrates the microstructural features of sample A2, for which the sampling location (quadrant rabbit) is close to the outer boundary of the FiE (Fig. 9a). Fig. 9b presents the whole BFI of A2 and Fig. 9c illustrates the DFI of its local field, showing any position on the profile is original martensite microstructure. Fig. 9d shows the SAD pattern with slightly elongated spots, which is the result of localized plastic deformation. Fig. 9e shows isolated spot pattern indicating only one grain within the diffraction area of 200 nm in diameter. In brief, the result of Fig. 9 shows that the microstructure underneath the fracture surface in the FiE region does not undergo grain refinement, which may be related to insufficient pressing during cycling because of the relatively faster crack growth rate in the FiE region.

Figure 9: Microstructural feature of sample A2 (RB,  $R = -1$ ,  $\sigma_a = 750$  MPa,  $N_f = 5.08 \times 10^7$ ), (a) SEM image showing sampling location (quadrate rabbit); (b) BFI; (c) DFI of dashed green box in (b); (d,e) SAD patterns of the left and right dashed yellow circles in (b).

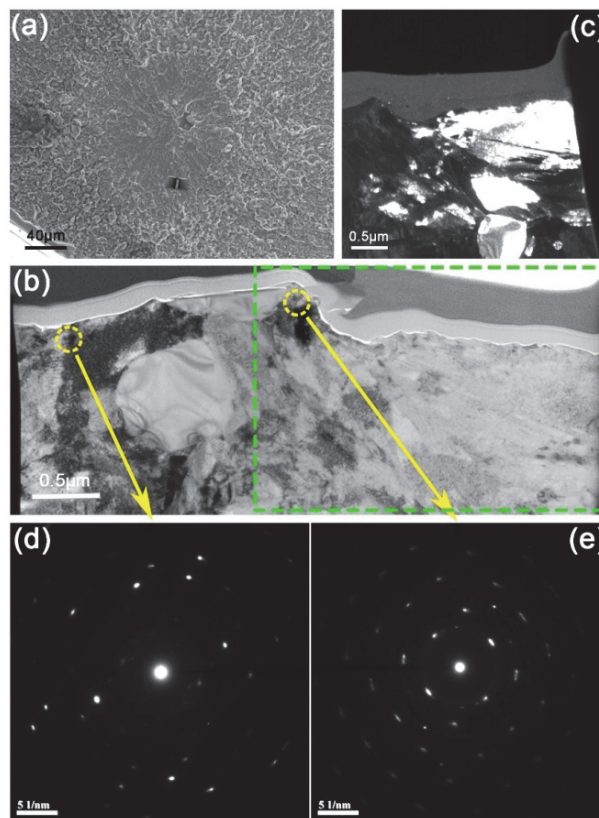
Fig. 10 illustrates the microstructural features of sample B5 (also cut from FiE region), similar to the results shown in Fig. 9. There is no evidence of microstructure refinement in spite of the high maximum stress ( $\sigma_{max}$ ), suggesting that plastic deformation ahead of crack tip cannot cause the formation of nanograins.

Figure 10: Microstructural feature of sample B5 (UL,  $R = 0.3$ ,  $\sigma_a = 430$  MPa,  $N_f = 8.70 \times 10^8$ ), (a) SEM image showing sampling location (quadrate rabbit); (b) BFI; (c) DFI of dashed green box in (b); (d,e) SAD patterns of the left and right dashed circles in (b).
