## Fracture analysis of AA6061-graphite composite for the application of helicopter rotor blade

**ABSTRACT.** The main objective of the work is to study the fracture behavior of AA6061-graphite material using both experimental technique and finite element simulation by considering helicopter rotor blade as a case study. From the case study, it has been observed that the helicopter rotor blade, made of AA6061, has been failed at the threaded portion of the hole. Experimental fracture toughness is carried out using the compact tension specimens as per ASTM standard testing procedure. Modeling of compact tension specimens and the threaded portion of the bolt hole was utilized to analyze the fracture toughness using a simulation tool. From the results and the comparison, it is recommended to use AA6061-9wt% graphite material as a replacement of AA6061 in the application of main rotor blades of the helicopter.

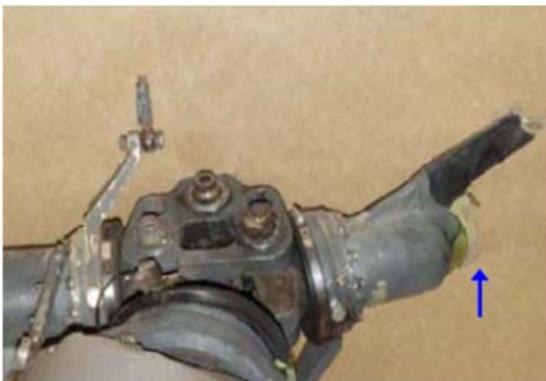
A rescue military helicopter crashed in the middle of a ferry flight towards an air terminal where an activity was planned. All team individuals endured fatal injuries [5-7]. The rescue military helicopter suddenly changed direction, and lost control due to the detachment of one of the rotor blades. The increase of fatigue crack growth reduces the strength of the blade to an extent that allowed the fracture to occur under normal flight loads. In view of the direction of failure of the helicopter, the Safety Investigation Board found part of the failed blade separated around 900 m before the disaster area. The failure analysis of the fractured blade was conducted and it was determined that part of the blade detached in the air due to which helicopter become uncontrollable. The main rotor blade is about 9 m long. The structural part of the blade is made of 6061-T6 aluminum alloy [5-8] and were 4.5 mm thick on average. The observations demonstrated various initiation points along an cut on the external and internal surface. Blade fracture happened because of the initiation of a fatigue crack in the bolt hole in the blade spar to root fitting joint. Fig 4 shows the root fitting of the blade, an aluminum alloy that accommodates the blade spindle and bearings, had fractured at the innermost bolt hole of the root fitting to blade spar joint.

Figure 4(a) recovered main rotor head assembly [6]

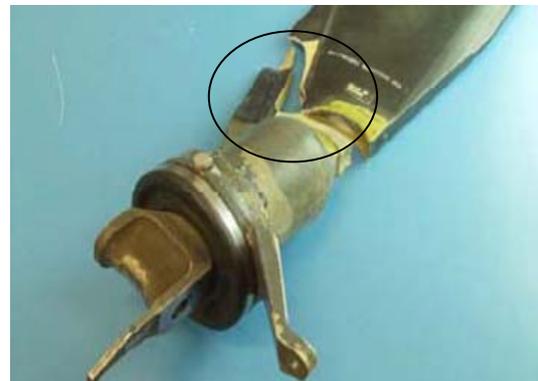
Figure 4 (b) fractured main rotor blade [6]

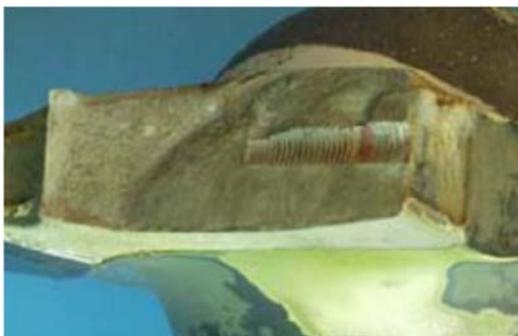
Figure 5(a) Fitting side, or inboard side, of the fracture [6]

From the Fig 5(a), (b) it is observed from the fracture surface features that fracture take place as a result of the progressive crack growth from the inboard bolt hole. The fatigue crack growth mechanism was used, i.e., crack initiation and crack propagation in response to the development of repeated alternating stresses throughout the operation.

Due to the failure of the adhesive bond (disbonding) at the bolt hole, failure of the main rotor blade occurs. The disbonding take place at spar end, and the root fitting of upper and lower blade skins as shown in Fig 5.

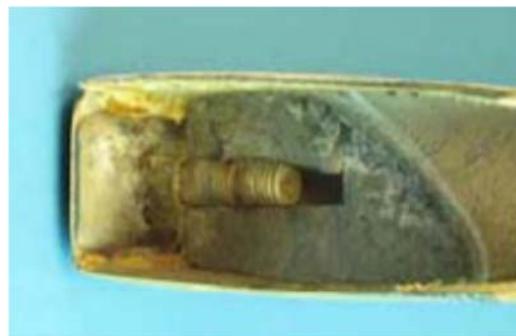
Figure 5(b) The blade side, or outboard side, of the fracture [6]

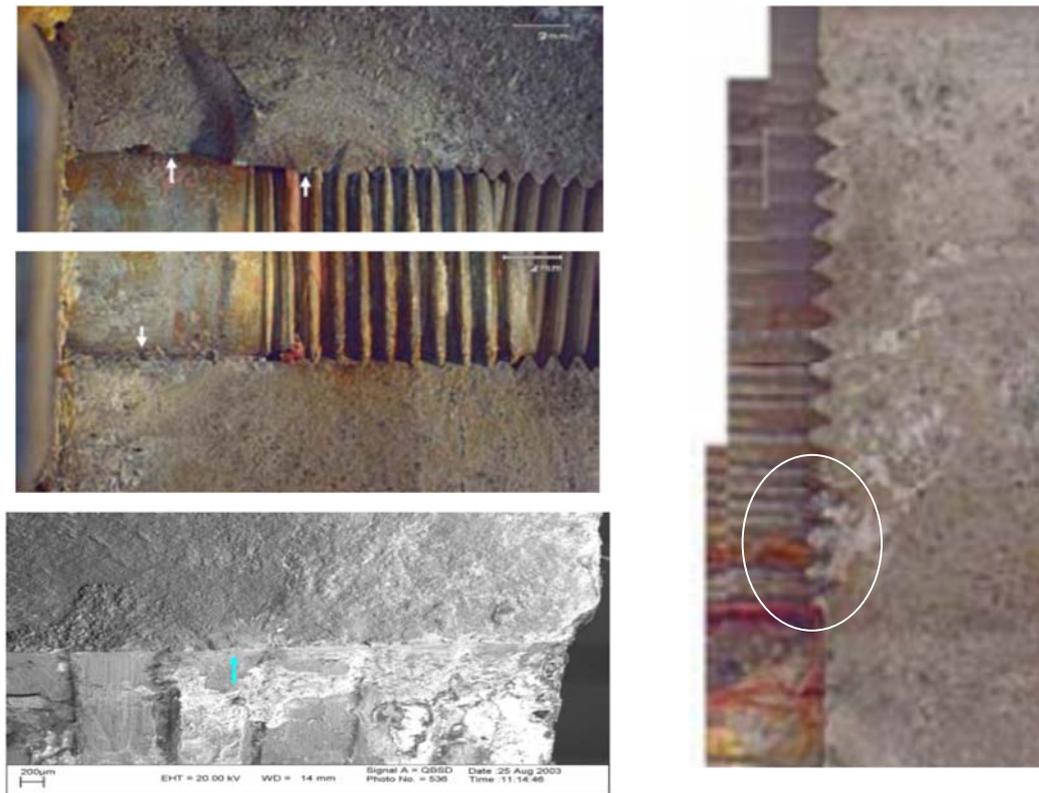
Figure 6: Sites of fatigue crack initiation (arrowed) [6].

From Fig 6, it is clear that moisture reacted with the crack surfaces. Followed by localized corrosion occurred in the counterbore (Fig 6 (b,c)). The nature of crack propagation marks signifies that fatigue crack initiation occurred at (a) the lower side of the bolt hole, (b) the thread on the upper side of the bolt hole and (c) the counterbore on the upper side of the bolt hole. From Fig 6 it is evident that the failure of the rotor blade occurred at the bolt hole and threaded portion of the bolt hole.

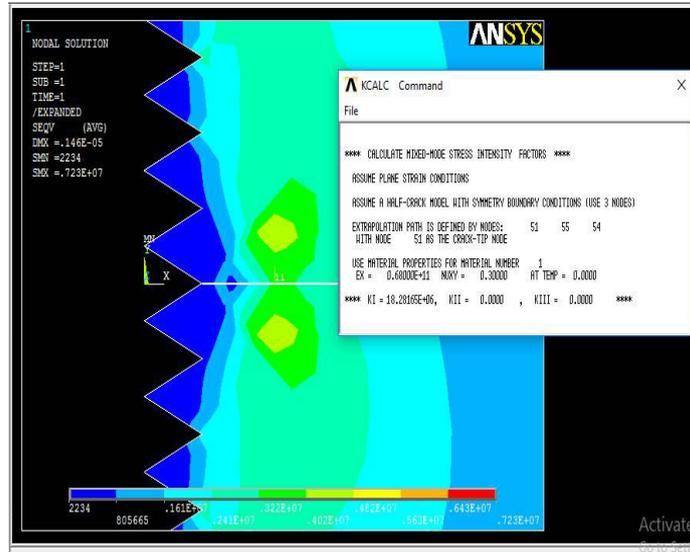
Figure9: Stress concentration factor K1 of AA6061-9% graphite for rotor blade.

Fig 9 shows the fracture toughness value of the AA6061 with 9wt% graphite particles and also shows the shape of the plastic zone. The shape of the plastic zone obtained indicates the plane strain fracture toughness [1]. The fracture toughness of the AA6061 with 9wt% graphite composite exhibits the higher values. Thus it is considered to be the better composition of the composite among tested. From the above results it is recommended that AA6061-9%graphite material can be considered as a potential rotor blade material as a replacement of AA6061 in the application of main rotor blades of the helicopter.

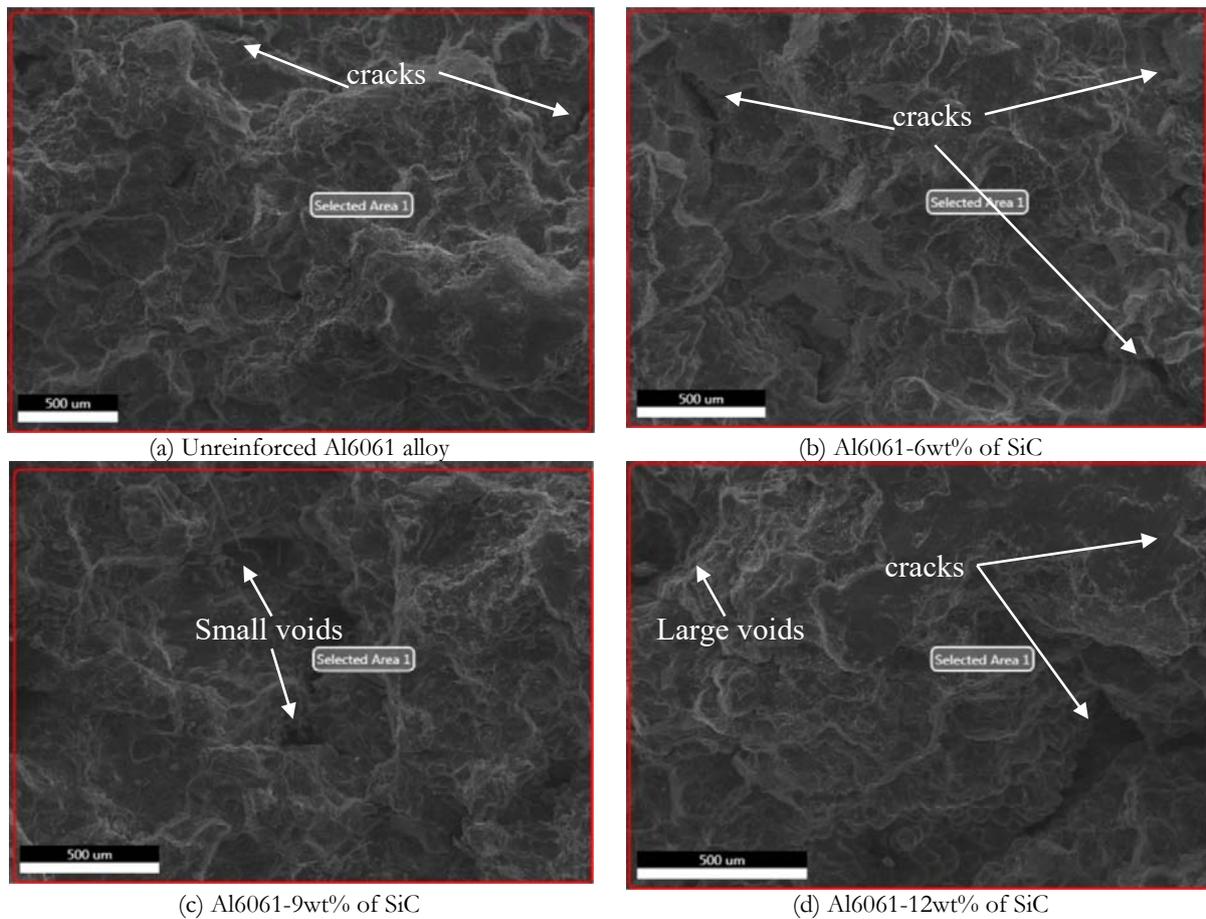
Figure 10. SEM Fractographic images

Fig10 shows the fractographic images of the Al6061-graphite composites obtained through the SEM. Fractographic images shows the formation of cracks at the unreinforced aluminum alloy and at 6wt% of graphite whereas at the 9wt% of graphite have the smaller voids which transforms into the cracks on loading. Thus the increased fracture toughness has been observed. The decrement in the fracture toughness after the 9wt%graphite, is due to increased hardness and increased crack initiation sites and reduced ductility. From the Fig. 9 it is also observed that, all the Al-graphite composites exhibits the dull and fibrous surface. Which means that the said composites have the ductile fracture. Thus the increased fracture toughness of the Al-graphite composite is the addition of graphite reinforcement. However the increment in other reinforcements such as SiC [14] in the aluminum composites exhibits the lesser ductility and fracture toughness values.
