Integrated Approach in Geophysical Investigation of Road Failure in Crystalline Basement Environment in South-western Part of Nigeria.

Olabanji Ojo^{1*}, Victor Adejumo², Obaromi Olubunmi²

¹Department of Geological Sciences, Osun State University, Osogbo, Osun State, Nigeria.

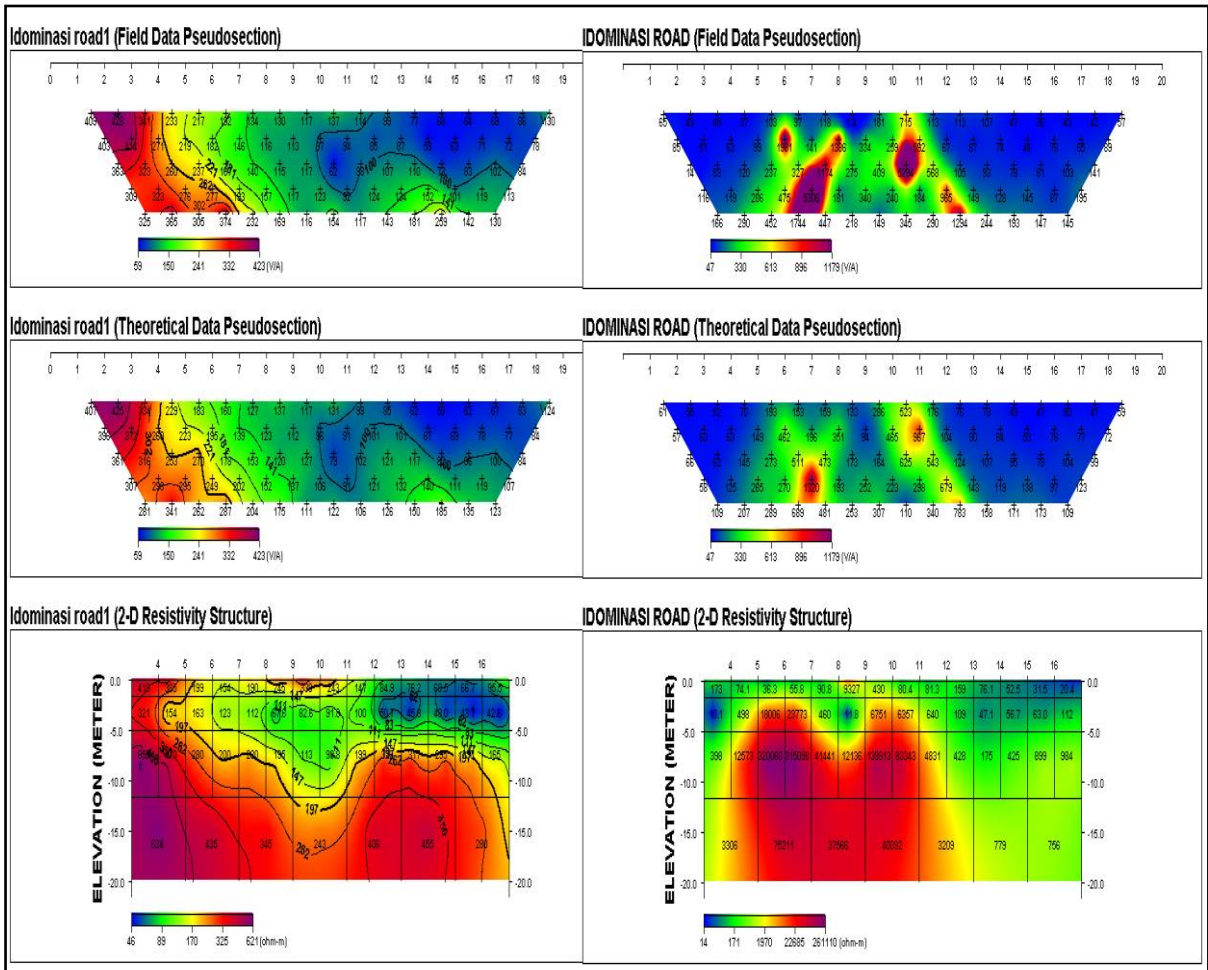
The results obtained from the dipole-dipole investigation reveals that the first part of the road is relatively stable (indicated in red colour in Figure 3) around Idominasi junction but progressively becomes unstable towards the south eastern direction (indicated in blue colour). This is exemplified by the low resistivity values obtained within the middle portion of the traverse.

The earlier part is underlain with thick lateritic material of about 20 meters' thickness with rubble of unweathered quartzite having resistivity values of between 325 Ω m and 621 Ω m. As the profile continues, failure

begins to be prominent and the resistivity begin to reduce to as low as between 17 Ω m to 46 Ω m (Figure 3)

The 2-D resistivity pseudosection reveals relatively low resistivity values in the range of 46 and 69 Ω m at a depth range between 0.6 and 5.0 m typical of clay material. The extent of the failure is prominent at the top 5 m while, the failure reduces gradually at relatively deeper depth. However, at about 10 m depth, the effect was not noticeable. As shown in Figure 3, the depth to failure is about 2 m deep while beyond this depth, there seem to be a relatively competent layer underlying the muddy interval.

Stratigraphically, the area under investigation is underlain by clay to a depth of about 4 m to 44 m and basement below the strata. Within the failed portion, the entire basement is almost weathered and almost lacking as the resistivity is as low as 17-117 Ω m. About 20 short GPR profiles were established during the course of the survey with the aim of revealing the water level, subsurface stratigraphy and the disturbed layer. Analysis of the GPR profiles (Figures 4-15) reveal that the cause of the failed portion of the road is the closeness of the water level to the surface coupled with the low resistivity clay material. This extends to a depth of about 0 to 4.5 or 5 meters.

Fig. 3: Pseudosection of the failed portion of the from North to South. (Red = competent highly resistive layer; Blue = low resistivity incompetent failed portion)

From the results obtained, since the clay is localized within a small portion of the road sandwiched within competent lateritic layers, towards the north western side and towards the south eastern part, the possible solution to the problem is to excavate the entire clayey layer in the study area, and replace with landfill material which can resist and withstand imposed wheel load. Excavation would be done to a depth of about 6 m to 7 m deep. Landfill materials to be used should be composed of homogenous and highly resistive lateritic material which is devoid of any significant geological features that could aid the development of swells and shrinking. This will go a long way to resuscitate the road and support heavy wheel load imposed on it.

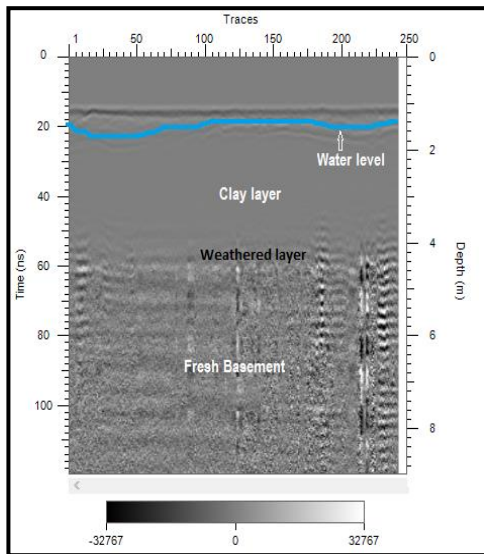
Fig. 4: GPR Radargram for Profile 1

This result is similar to that obtained using the dipole-dipole technique. The material that constitute the overburden is rich in clay and varies in thickness from about 4 – 5 meters. The depth to the water level also varies from 1.40 meters in Figure 4 to 2.0 m in Figure 5. This result is also confirmed in the dipole-dipole that was run in the area which reveals the depth of 4.5 to 5 meters to the incompetent less resistive layer having resistivity values of 46 and 89 Ω m in Figure 4 and resistivity values of 14 and 171 Ω m in Figure 5. This observation is also obtained in Figures 6 to 15.

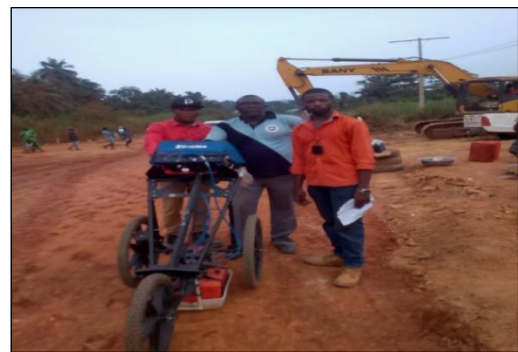
Figure 16: Picture of the failed portion of the road and investigation using the GPR instrument
