# Integrated approach to structural diagnosis by non-destructive techniques: the case of the Temple of Minerva Medica

**Citation:** Ivan Roselli, Angelo Tati, Vincenzo Fioriti, Irene Bellagamba, Marialuisa Mongelli, Roberto Romano, Gerardo De Canio, Mariarosaria Barbera, Marina Magnani Cianetti, Integrated approach to structural diagnosis by non-destructive techniques: the case of the Temple of Minerva Medica, Acta IMEKO, vol. 7, no. 3, article 4, October 2018, identifier: IMEKO-ACTA-07 (2018)-03-04

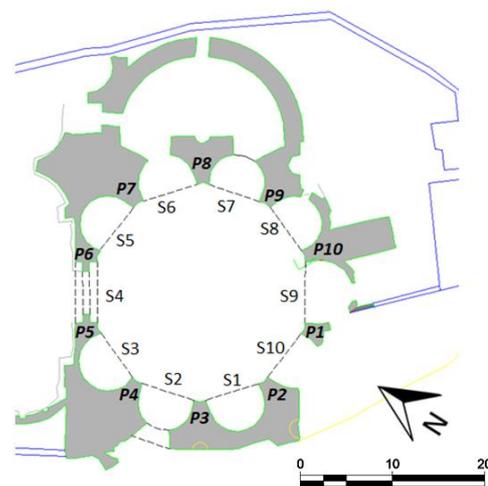
Figure 2. Decagonal plan of the main hall with sides (S1-S10) and pillars (P1-P10) nomenclature.

The structure was initiated in early 4<sup>th</sup> century A.D. as a majestic building. The main hall of the complex was probably a nymphaeum. It had a decagonal polylobate plan with a diameter of 25 m and an overall height of 32 m. After several partial collapses during the past centuries, the size of the main hall is today almost unchanged, except for the height, which is currently reduced to only 24 m after a major dome collapse occurred in mid-19<sup>th</sup> century. The main hall presents two orders of arcades: on each of the ten sides (named as in Figure 2) a

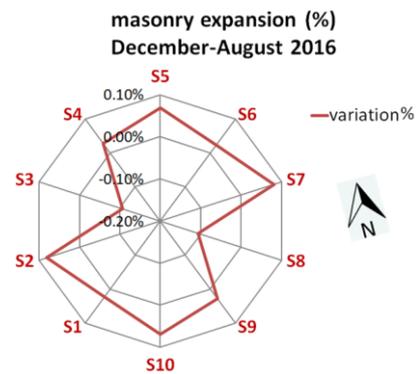
Figure 3. Variation (%) of opposite sides distances between 3D laser scanning surveys of August and December 2016.

The laser scanner measurements were acquired in summer of 2016 (August 5th) and in winter of 2016 (December 20th), when air temperatures were supposed to be the highest and the lowest of the year, respectively. Both acquisitions were carried out at 12 a.m., so that solar beams direction was essentially affected only by the season and not by the daytime, in order to analyse the seasonal effects neglecting the day/night cycle effects. The instrumentation used comprised a Riegl Z360 equipped with a Nikon D100 digital camera. The nominal angular resolution is  $0.0025^\circ$  horizontal and  $0.002^\circ$  vertical, while range accuracy was  $\pm 6$  mm. Through the use of retro-reflecting targets, which were located at each pillar at the height 2.5 m from ground level, the two surveys could be compared by matching the targets positions as reference points. This 3D geometrical reconstruction by laser scanner was the base both for measurements of distances between walls at unreachable points and for the mathematical modelling for successive structural analyses. The plan of the main hall with sides (S1-S10) and pillars (P1-P10) nomenclature is depicted in Figure 2. In particular, the ten diameters obtained as the distances between the internal walls of the opposite sides were calculated from both summer and winter surveys in order to assess the masonry expansion in each horizontal direction.

The overall expansion is the combination of the effects of masonry temperature and moisture deformations. In fact, construction materials are known to expand when heated and contract when cooled. In particular, ancient roman masonry, such as the one constituting the walls of the temple, have typical values of the thermal expansion coefficient that lie in the range of  $3-8 \times 10^{-6} \text{ }^\circ\text{C}$  [5]. On the other hand, this historic masonry is also capable of absorbing water and, consequently, expand and contract again on drying. The thermal expansion is generally more intense than moisture deformations in case of high temperature excursion and dry climate. Nonetheless, as the December survey was carried out after a two-day rain of 12 mm, the masonry was substantially wet to near saturation. On the contrary, the August survey was performed in a very hot and dry period. The found masonry expansion, expressed in terms of the percent variation (%) between 3D laser scanning surveys of August and December 2016, is illustrated in Figure 3.

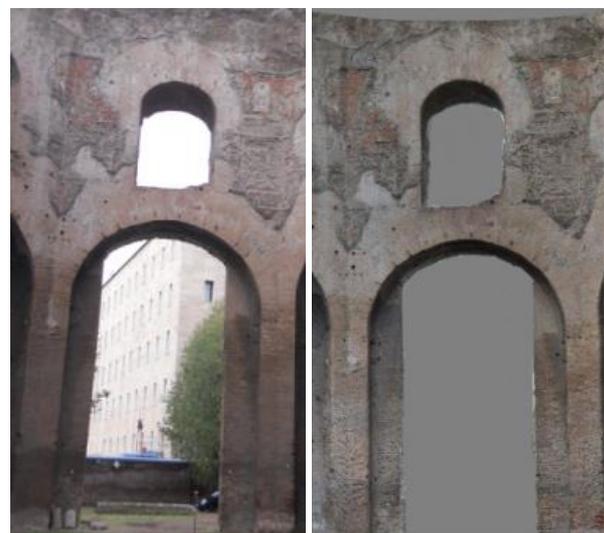
Figure 4. Digital photo (left) and related 3D texture (right) of northwest side S4 of the monument.

Figure 4 shows a comparison between the raw digital image of side S4 and its reconstructed 3D rendering with texture after SfM processing. Background was eliminated so as to facilitate crack pattern recognition and analysis.

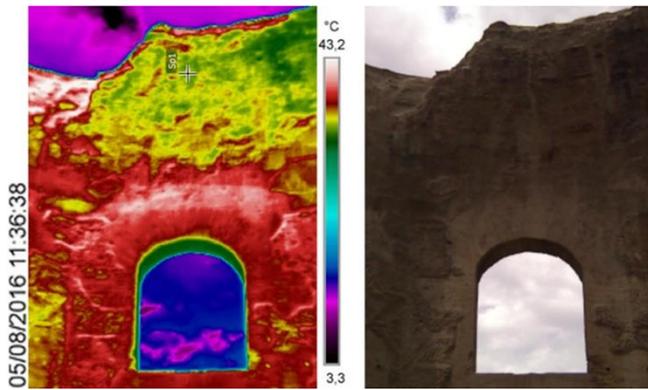
Figure 5. Thermal image of upper floor arcade on the northwest side (S3) of the monument (left) and corresponding photo (right).

The building images were recorded from the centre of the main hall and were subdivided in 10 ground floor and 10 upper floor views, corresponding to the sides of the decagonal plan (Figure 5). The thermal images were captured at about 12 a.m. on the same two dates as the laser scanner surveys. A temperature diagram was obtained as a function of the walls solar exposure (ground and upper floor sides) for all acquired seasons, putting into evidence the thermal differences between walls. Minimum, maximum and average values of temperature excursion ( $^\circ\text{C}$ ) between thermal imaging of August and December 2016 are depicted in Figure 6.

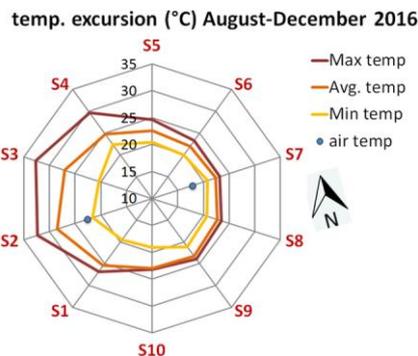
Figure 6. Minimum, maximum and average values of temperature excursion (°C) between thermal imaging of August and December 2016 at 12 a.m. Air temperature excursion is also shown (blue dots).

Temperature excursions were more than 30 °C between the maximum temperature values of the masonry recorded in August and in December surveys. The temperature of the walls was higher in the upper arcade and particularly in sides S2, S3 and S4 (north-western sides of the monument), where temperatures reached 40 °C in August.

This was a result of the direct solar beam exposure of their upper inner wall-faces due to the big hole left by the collapsed dome. Conversely, the walls on the eastern and southern sides (S6, S7, S8, S9 and S10) revealed maximum values of only 34-35 °C. In the December survey the walls temperature resulted more uniform, increasing only slightly, from 8 °C at the bottom to 12 °C at the upper arcade. Solar beam direction was approximately the same, since the daytime of measurements was the same, but the effect of direct solar irradiation was very limited because it was a very cloudy day.

The excursion of the air temperature recorded by the microclimatic stations is indicated in Figure 6 where it can be

compared with the temperature excursion by thermal imagery. Air temperature varies with less ample excursion than the walls temperature, as expected in consequence of typical masonry thermal behaviour.

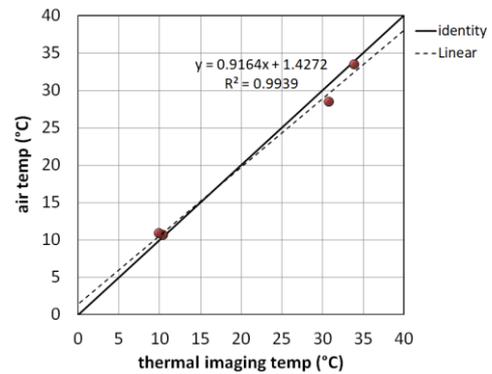
Figure 7. Correlation between air temperature and thermal imaging temperature at the same points.

Consequently, the measured air temperatures could be correlated with the corresponding temperatures in the thermal images at the same positions. In Figure 7 the obtained correlation is illustrated. It shows that masonry temperatures resulted slightly lower than air temperatures in the December survey and, vice versa, slightly higher in August.

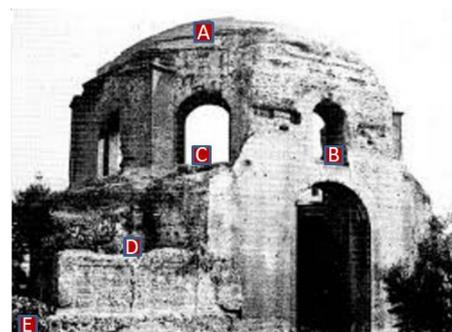
Figure 8. Ambient vibration measurement points on the main façade of the monument (view from North).

To assess the dynamic behaviour of the building, several measurement stations were located on the façade of the monument to acquire ambient vibration. They were made up of a digital recorder equipped with a triaxial velocimeter provided with a GPS antenna for time synchronization. The instruments were located as in Figure 8, simply laid on horizontal surfaces reachable by scaffoldings, at ground level, at windows and on the roof. Each measured position was acquired for at least 20 minutes at a sampling frequency of 200 Hz, as in previous similar studies of historic masonry buildings [9].

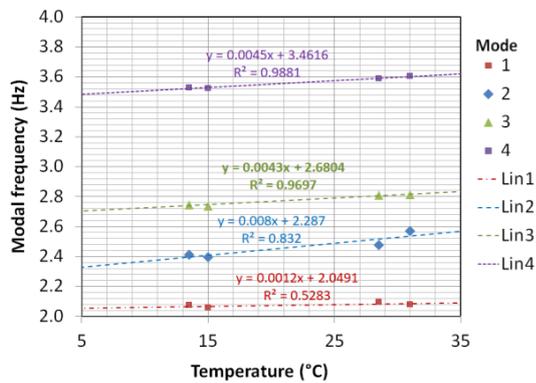
Figure 9. Influence of temperature on first four modal frequencies of the monument.

The initial outcomes showed that the considered modal frequencies resulted quite stable, though a slight variation was actually revealed. In fact, modal frequencies were a bit higher in spring and summer acquisitions. Consequently, the influence of the masonry temperature on the obtained frequencies was investigated. In particular, a remarkable correlation was found between the first four modal frequencies and the temperature, as showed in Figure 9. As quite common in historic buildings, the modal frequencies increased slightly with the temperature. However, recorded variations were limited in the range of 2-6 %, which is substantially coherent with a temperature excursion between about 10 °C and 30 °C.

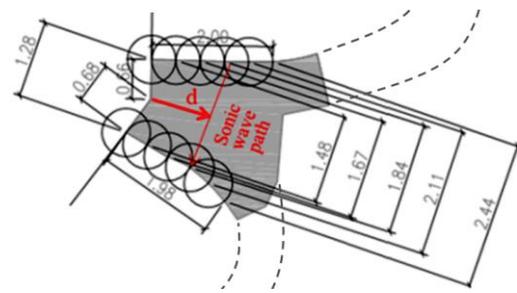
Figure 10. Pillar P1 plan view with configurations of sonic wave velocity measurement (unit is m).

The acquisition configurations were as depicted in Figure 10 for pillar P1. It shows the sonic path length and the meaning of  $d$ , which is the distance from internal pillar face to the path line. Because of the particular geometry of pillars, the acquisition with the utilized instrumentation was possible only on the two radial faces. In particular, as the points on the outer sides of pillars could not be acquired, a rectangular grid could not be performed and a representative 2D tomography could not be obtained. Consequently, only 1D sonic wave velocity distribution could be detected (in radial direction), which however provided interesting indications.

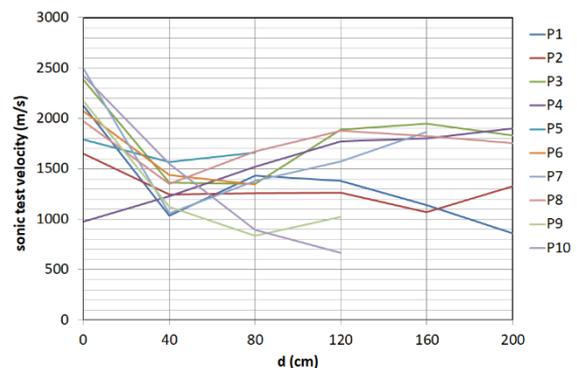
Figure 11. Sonic test velocity recorded at each pillar (P1 to P10) in function of the distance from internal face ( $d$ ) defined as in Figure 10.

In particular, in Figure 11 a graph of the sonic test velocity recorded at each pillar versus  $d$  is depicted. Initial values ( $d = 0$ ) tend to decrease at higher values of  $d$ , indicating poorer material properties of the core (*opus caementicium*) with respect to the wall-face brickwork layers (*opus latericium* or *mictum*). The low initial value of pillar P4 is due to a crack in the wall-face layer. The lowest values were measured in pillars P9 and P10 at  $d$  in the range 80-120 cm. For  $d > 120$  cm the lowest values were obtained for pillars P1 and P2.

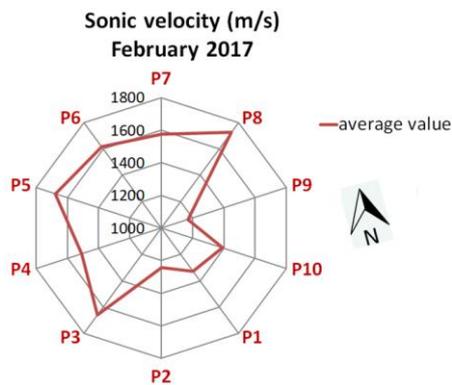
Figure 12. Average values of sonic test velocity recorded at each pillar

The diagram in Figure 12 illustrates the average values of sonic velocity recorded at each pillar. It suggests that pillars from P3 to P8 (clockwise from southwest to northeast) are characterized by higher average consistency than the remaining

pillars in east and south sides.

It is worth noting that pillar P1 was entirely reconstructed in 1846, when a major restoration intervention was carried out to rebuild the portion of the ground floor arcade that goes from P10 to P2 clockwise. On the other hand, P9 and P10 values are very low, but they do not apparently show any external defect, as confirmed by their good values in the first 40 cm of d, which may indicate that these pillars have a different internal structure.
