Different damage observed in the villages of Pescara del Tronto and Vezzano after the M6.0 August 24, 2016 Central Italy earth- quake and site effects analysis

Abstract

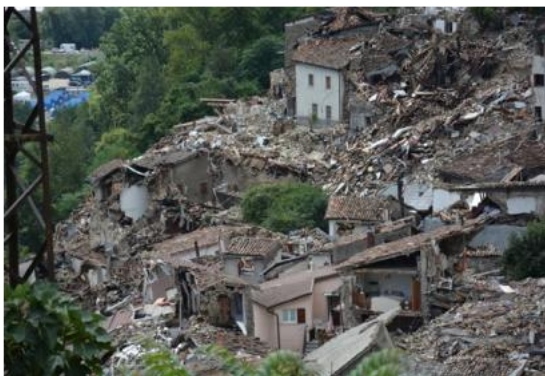
The extent of damage in Pescara del Tronto is clearly visible in Figure 2-a) showing the post-earthquake condition of a portion of the village. Figure 2-b) displays a partial collapse of a masonry building pointing out the poor quality of masonry walls without any connection between wythes. In some cases, the combined effect of in plane actions and out plane actions further exacerbated by pushing wooden roofs was responsible for the collapse. Heavy damage also occurred to buildings with reinforced concrete (RC) structure. An example is reported in Figure 3-a) and b), where the heavy damage occurred to a four storey RC building in Pescara del Tronto is shown. The infill walls of the second storey totally collapsed. They were made up of two 12 cm clay hollow brick layers with an interposed layer of insulating material.

Figure 2: a) Overview of Pescara del Tronto most damaged area and b) Collapse of a typical masonry building.

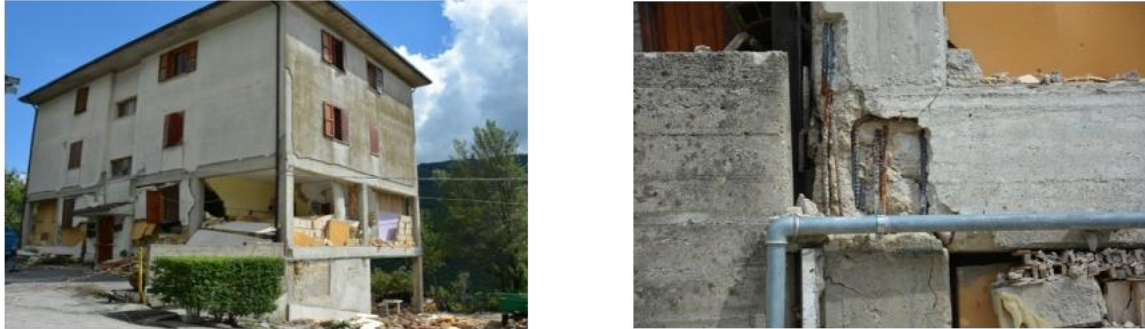
Figure 3: a) Reinforced concrete building in Pescara del Tronto, b) Detail of the damage to a beam-column joint.

Some structural damage was also found in a beam-column joint displayed in Figure 3-b). Concrete spalling affected the joint panel where no hoops are visible as expected considering design rules given in the building codes then in force (Masi et al., 2013; Manfredi and Masi, 2014; Masi et al., 2014). In fact, the presence of deformed reinforcing bars indicates design and construction could date back to the early 1980's (Masi et al., 2015), when Arquata del Tronto was classified as a seismic zone, forcing engineers to consider seismic activity without particular attention to structural details. A possible interaction with a retaining wall could also be partially responsible for the undesired seismic behaviour of the building. Both severity and extent of damage in Vezzano were

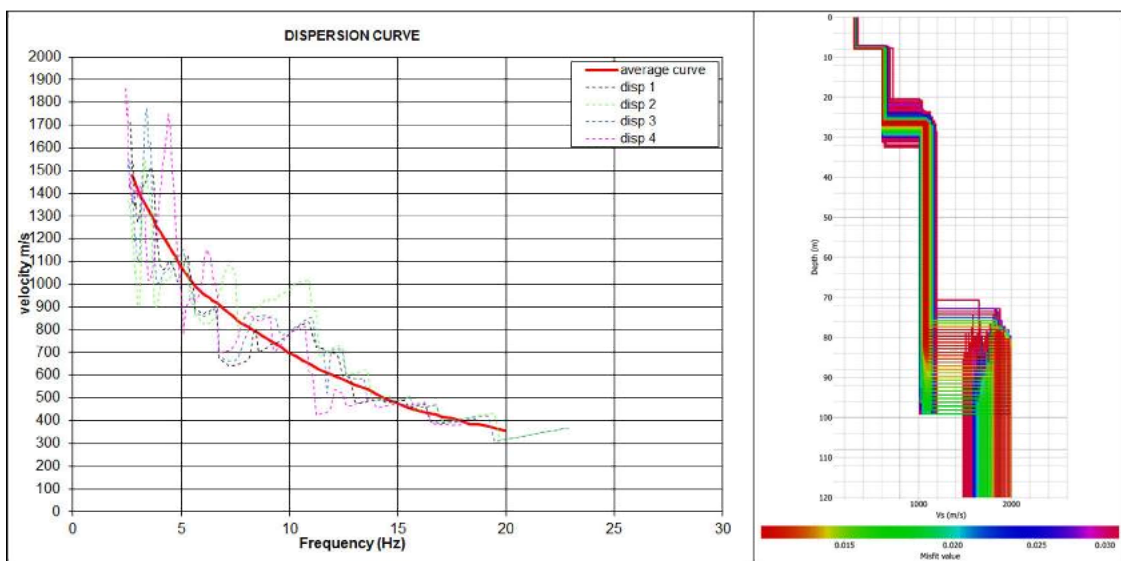
with 8 msec sampling rate. The set-up of arrays was with 24 geophones with 4.5 Hz frequency, L-shaped arrays with variable inter-distance and length in the 190 – 50 metres range were used for ESAC. Noise acquisition was carried out with a 125 msec sampling rate for a length in the range 3-40 minutes; Figure 10 reports the VS velocity profile estimated by ESAC analysis: two impedance contrasts are present at about 10m (VS from 300 to 600m/sec), probably due to the discontinuity between slope deposits and the underlying Laga Formation, and at about 30m (VS from 600 to 1000 m/sec), probably due to the different lithostratigraphic members, from pelitic to arenaceous, in the frame of the Laga Formation.

Figure 10: Dispersion curve and VS profile estimated by ESAC analysis in Pescara del Tronto.
