## Crack path in aeronautical titanium alloy under ultrasonic torsion loading

A. Nikitin, C.Bathias

**ABSTRACT.** This paper discusses features of fatigue crack initiation and growth in aeronautical VT3-1 titanium alloy under pure torsion loading in gigacycle regime. Two materials: extruded and forged VT3-1 titanium alloys were studied. Torsion fatigue tests were performed up to fatigue life of  $10^9$  cycles. The results of the torsion tests were compared with previously obtained results under fully reversed axial loading on the same alloys. It has been shown that independently on production process as surface as well subsurface crack initiation may appear under ultrasonic torsion loading despite the maximum stress amplitude located at the specimen surface. In the case of surface crack initiation, a scenario of crack initiation and growth is similar to HCF regime except an additional possibility for internal crack branching. In the case of subsurface crack, the initiation site is located below the specimen surface (about 200  $\mu\text{m}$ ) and is not clearly related to any material flaw. Internal crack initiation is produced by shear stress in maximum shear plane and early cr

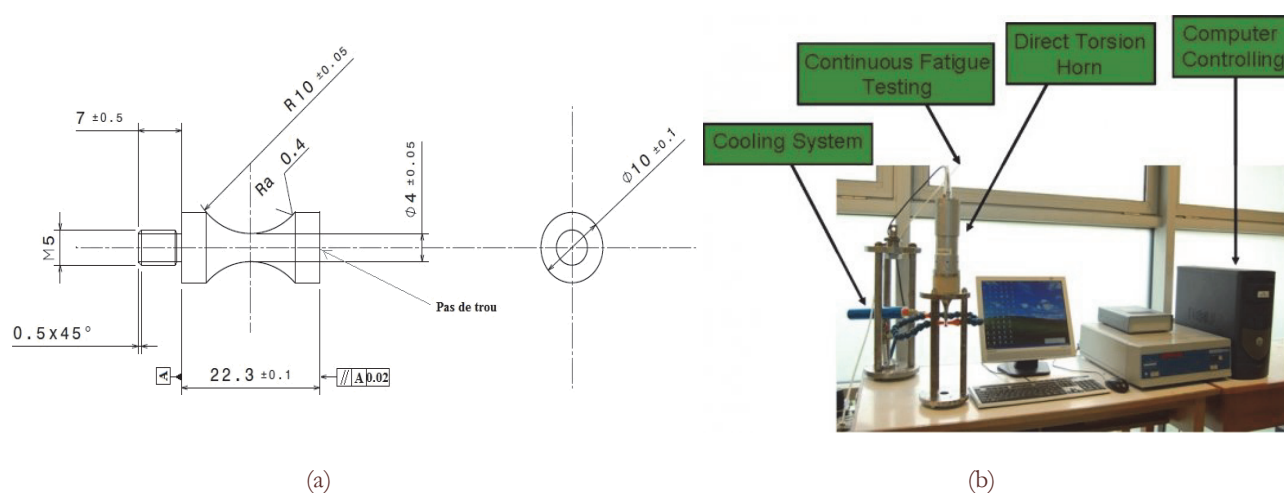
Figure 3: (a) Geometry of ultrasonic torsion specimen and (b) ultrasonic torsion testing system.

Torsion fatigue tests were performed on specimens, designed according to ultrasonic concept applied to torsion [3, 14] and taking into account dynamic elastic properties of materials at 20 kHz (Tab.2). Specimens made of forged VT3-1 were cut from the rim part of compressor disk along an axis of disk symmetry. Specimens made of extruded VT3-1 were machined from bar so that specimen's longitudinal axis is the same than extrusion direction. Geometry of ultrasonic torsion specimens is presented on Fig.3a. Working section of specimen was polished by emery papers from grade 600 to 1000. Fatigue tests were performed continuously (without pulse - pause) by using a self-designed ultrasonic torsion system [14], (Fig.3b) up to fatigue failure or run out limit of  $10^9$  cycles. All the tests were performed at room temperature with permanent compressed dry-air cooling. An infrared camera was used for monitoring surface temperature of specimen during fatigue tests. Result shows that there is now significant self-heating effect in VT3-1 titanium alloy under torsion loads [15].

The calibration of the testing system was performed with strain gauge and Vishay conditioning device with a large bandwidth (up to 100 kHz). Calibration shows a perfect linear relation between applied tension and measured deformation.
