Evaluation of the behaviour of reinforced concrete beams repaired with glass fibre reinforced polymer (GFRP) using a damage variable

Citation: Cunha, R. N., Oliveira, K. M., Brito, A. G. L. R., Vieira, C. S., Amorim, D. L. N. F., Evaluation of the behaviour of reinforced concrete beams repaired with glass fibre reinforced polymer (GFRP) using a damage variable, *Frattura ed Integrità Strutturale*, 57 (2021) 82-92.

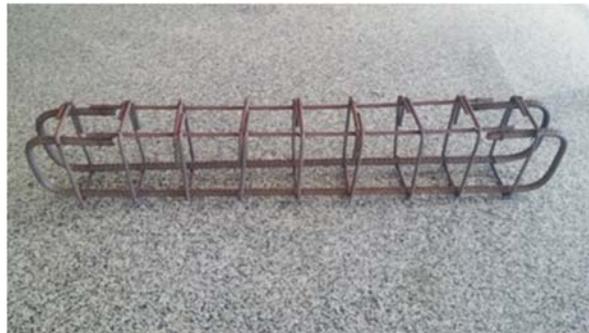
Figure 1: Reinforcement of the beam.

The four reinforced concrete beams utilised in the experiments were designed to collapse by bending moment. The beams cross section dimensions are 10 cm of base and 15 cm of height, while its total length is equal to 70 cm and the span (distance between supports) is 60 cm. Longitudinal reinforcement is comprised of two steel bars with 10 mm of diameter, which represents area of steel equal to 1.57 cm², and yield stress of 500 MPa. Transversal reinforcement is formed by steel stirrups of yield stress of 600 MPa and 5.0 mm of diameter, which is equivalent of 2.12 cm²/cm of area of steel. Fig. 1 shows the reinforcement of one of the beams.

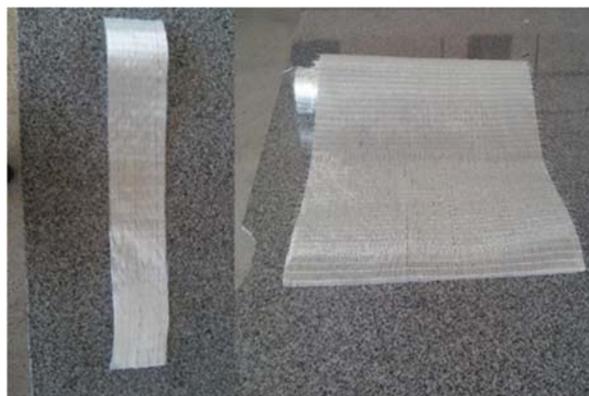
Figure 2: Unidirectional glass fibre fabric.

One of the casted beams is experimented up to collapse and the other ones were reinforced with unidirectional glass fibre fabric VEW130 (Fig. 2), after certain ultimate load ratios. Such reinforcement was manufactured in the USA and it was applied with a Brazilian brand epoxy resin. The data of the glass fibre, provided by the manufacturer, is described in Tabs. 2, 3 and 4.

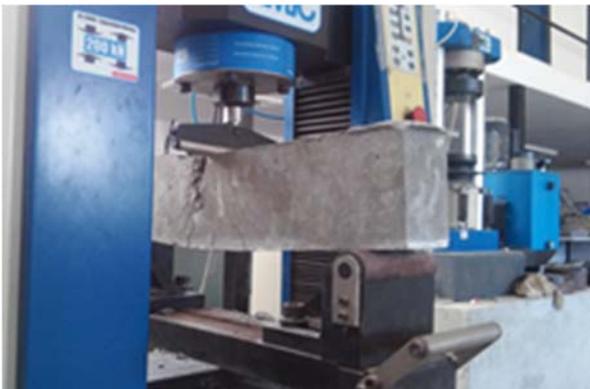
Figure 3: Beam during the test.

The four beams were demoulded 24 hours after casting and cured submerged during 28 days. After curing, the reference beam (RB) was subjected to a cyclic 3-point bending test with displacement control (Fig. 3), with test velocity of 1 mm/s. In order to obtain the maximum strength, the beam was loaded until to rupture, in 14 loading cycles. Then, on the remaining three beams, loads equivalent to 100% (beam #1), 80% (beam #2) and 60% (beam #3) of the maximum force were applied, with 7, 5 and 5 loading cycles, respectively. The tests were performed with universal testing machine EMIC/INSTRON model DL 2000.

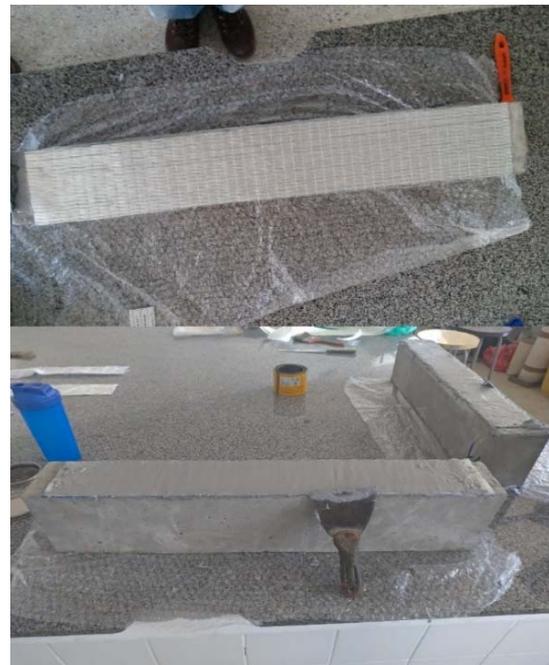
Figure 4: Glass fibre application.

After the bending tests, the beams were reinforced. Initially, a layer of epoxy resin was applied to serve as an interface between the concrete and the glass fibre fabric. After that, the fibre was applied on the entire longitudinal section and, finally, another layer of resin was added (Fig. 4). The resin cured after a week and then further tests were made.

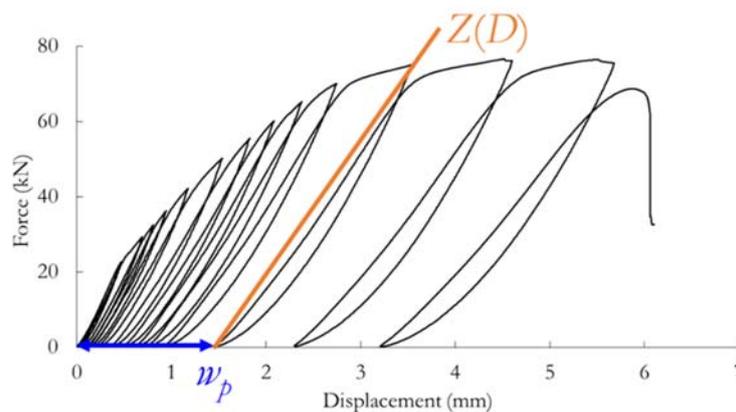
Figure 5: Graphical representation of damage measurement.

where P is the applied load, w is the total deflection, w_p is the plastic/permanent deflection that measures the steel reinforcement yielding and $Z(D)$ is the current stiffness of the beam (Fig. 5), considering concrete cracking, given by:

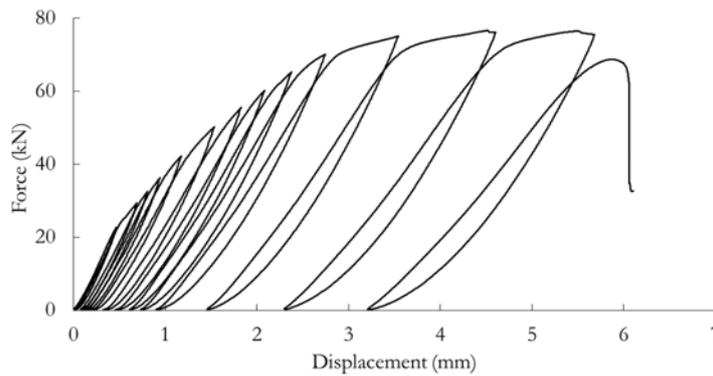
Figure 6: Force-displacement response of the reference beam.

The cyclic flexural test of the reference beam is presented in Fig. 6. The bearing capacity of the beam is 76.62 kN and its ultimate damage is 0.53. The damage for each cycle of the reference beam and the repaired beams #1, #2 and #3 are depicted in Fig. 7 in terms of the bending moment at the centre of the beam.

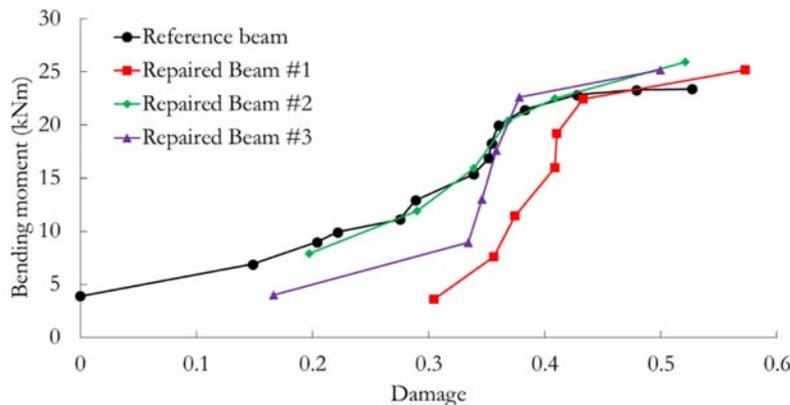
Figure 7: Bending moment and damage values at each cycle.

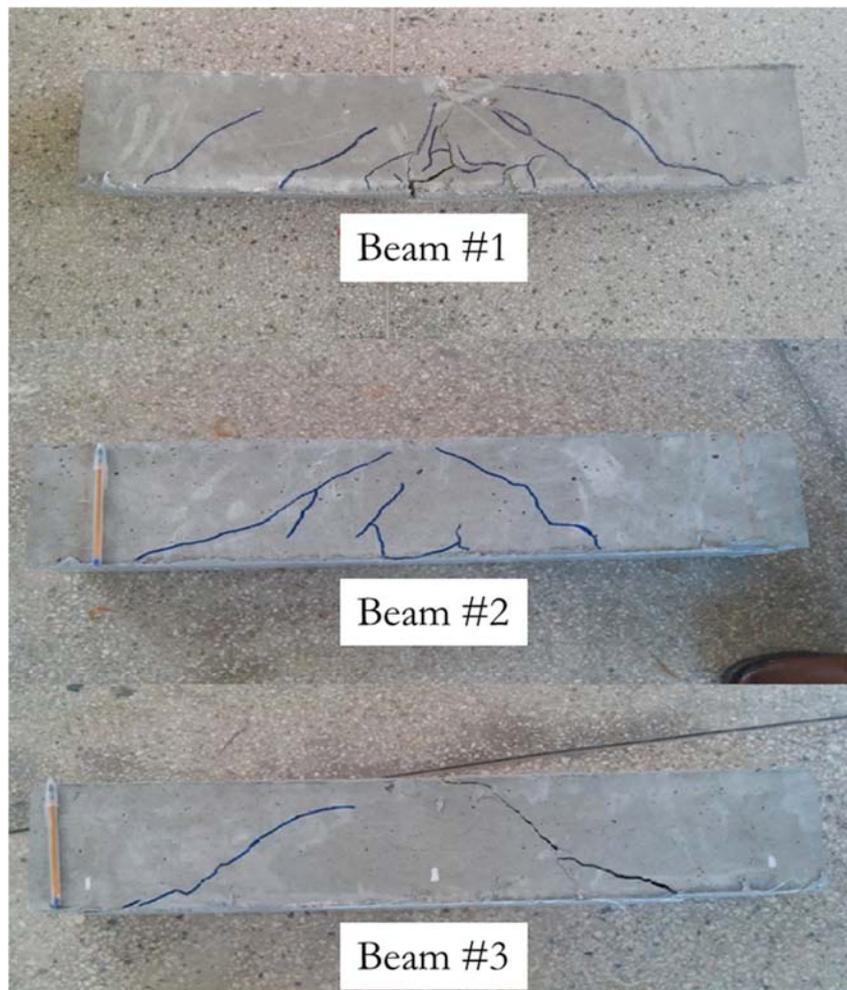
Figure 11: Cracking pattern of the repaired beams.

An important observation during the experiments is that the collapse mechanism of the repaired beams shifted to shear (Fig. 11). Note that the repaired beams presented similar bearing capacity, which is close to the shear strength of such beams, calculated as $F_s = 85.54 \text{ kN}$ (4) using the Brazilian Standard Code NBR 6118 [36]:

The behaviour shift is evident for beam #1 since there are cracks at the mid-span characterising flexure failure. These cracks appeared in the pre-loading step i.e. when the beam was without GFRP. Then, after repair, such beam presented severe shear cracks (Fig. 11). The mid-span cracks at the beams #2 and #3 are not severe, since both were repaired after submitted to loads considerably smaller than the collapse force. However, in these last two beams, the shear cracks occurred as well.
