# An agenda for the Management of contemporary Sustainable houses

JOURNAL OF CONTEMPORARY URBAN AFFAIRS (2017) 1(2), 33-37.

### 1.1.4 Case Study: The Community Building

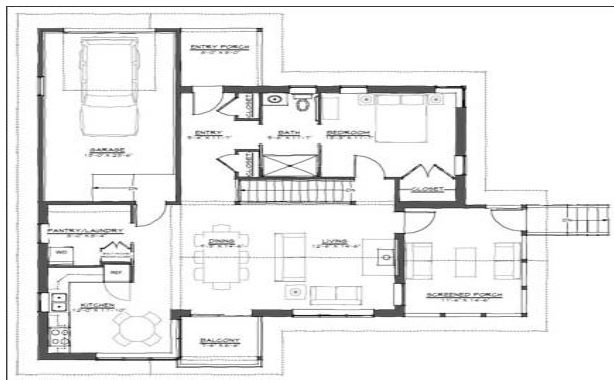
**Figure 2.** The Community Building, Upper Floor.

First (upper) floor: In the floor plan above, note that the north (top) wall has fewer windows than the south (bottom) wall, which overlooks Stone Mountain and the valley. Note also the differences in wall thickness: the thicker walls are a foot of blown-in, dense-packed cellulose, with an R-value of 45. Ceilings throughout are R-55. Note the ramp from the garage into the party and kitchen, the first floor of each house is designed using ADA (Americans with Disabilities Act) standards and approved by a consultant from Independent Living Resources. The entrance is ramped; doorways are wide enough for wheelchairs, and there are no thresholds. The first-floor bathroom is handicapped accessible. Each house has one garage space, a mudroom, a screened porch, and storage space.

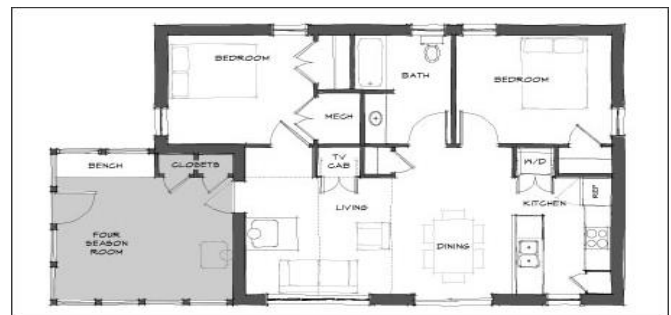
**Figure 4.** Mini House Floor Plan.

The Mini House echoes the design and planning of the Essential House on a smaller scale. A garage is optional.
