Characterization of historical coating mortars of La Ceramo factory in Valencia

Marcela Luana Sutti¹, Maiara Oliveira Silva de Aguiar¹,
Cesar Fabiano Fioriti¹, Maria Paula Hêngling Christófani¹

¹ Department of Planning, Urbanism and Environment, Universidade Estadual Paulista (UNESP)

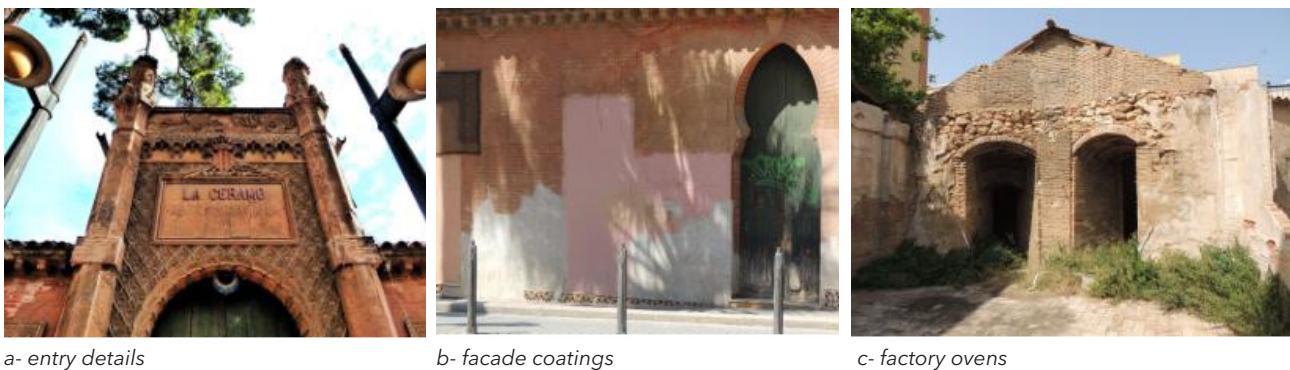
Figure 2.
Images of the La Ceramo factory

The first block main facade consists of an entrance with an arc of evident arab influence, supported by two columns which the right-hand column was lost over time and the column on the left is all smooth containing capital, while the upper part consists of an abacus with interlaced decorations. The arc is also included within a large rectangular decorated frame, consisting an iconic rhombic pattern, also with

obvious arab origin. Finally an effigy above the arch, which also shows the city of Valencia's shield and the name of the factory, as shown in figure 2 [a]. The main access door is run down, made of wood and painted in green color, leads to the main patio of the factory. To the right of the entrance door there is another side entrance leading directly to the building where the ceramic production processes were present. Other openings, containing Arabic-style frames, are also present on the facade, now protected by safety nets (Pagliuca, 2017).

The facade observed in figure 2 [b] does not contain many of the original coatings, existing vestiges of an older mortar in the walls, but what prevails is a coating of ordinary mortar, regularizing what was before collapsing.

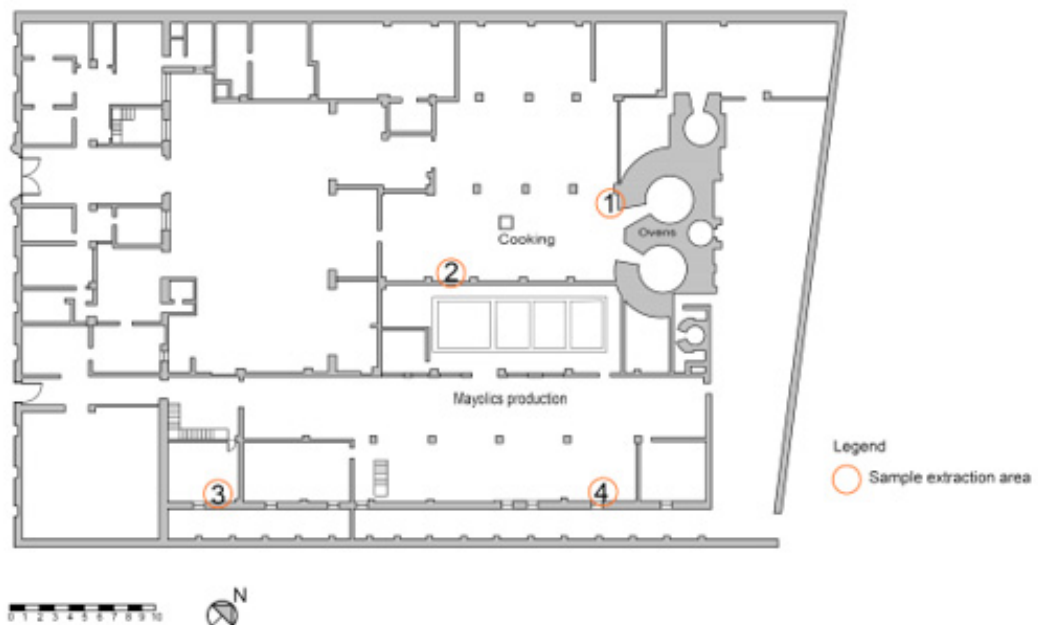
Figure 3.
Sample extraction areas

The removal of mortar coatings samples for study in this work was carried out inside the La Ceramo factory. All the pieces were taken from inside the factory masonry, because, as the building description shows, the outside part was not able to remove the cover layer, while inside the building, the chosen areas presented better conditions for this practice. Sample removal areas are marked in figure 3 and numbered from 1 to 4, as they will be displayed from this point of work.

There are two study areas in each of the blocks chosen, the samples of areas 1 and 2 were in the oven block, and 3 and 4 in the production block.

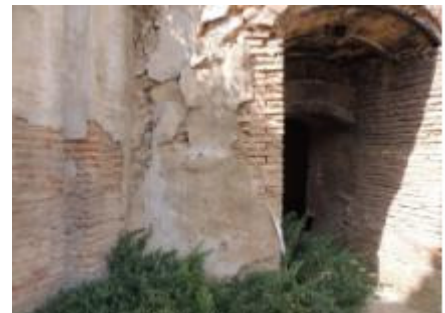
a- area 1

Samples from area 1 were removed from a wall of the oven itself (figure 4 [a]), which has a sacco-type masonry structure. The coating was already very aggravated and compromised, with a large area with erosion, detachment and disintegration of the mortar, and there were practically no significant cracks amid lack of coating in the area. Dirt has also been

observed, but there are no manifestations of moisture spots, efflorescences or biological colonization.

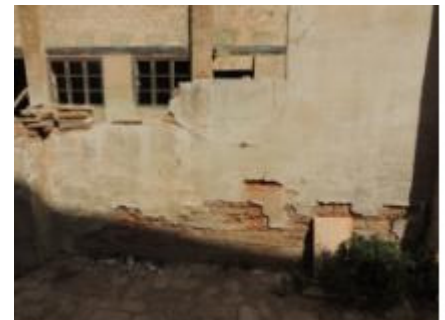
b- area 2

Samples from area 2 were removed from what in their original state was an entire wall (unlike figure 4 [b], which shows the state in which it was found in situ surveys), the region was also originally covered. The area shows loss of mortar at the lower part of the wall, being possible the visualization of different layers of mortar, the external one already totally unobstructed, and the second with some remaining parts. There are few cracks, some dirt and a large region where there was loss of coating adhesion.

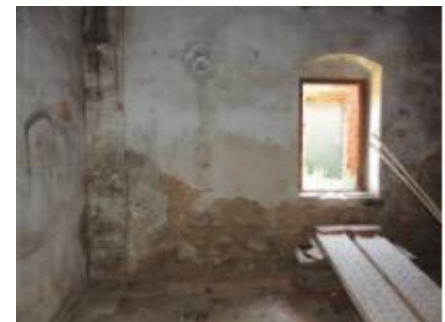
c- area 3

Samples from area 3 were removed from a fully covered room with few openings, only the window can be seen in figure 4 [c] and a door that leads to a room also covered, meaning that the wall did not receive direct sunlight. The wall, one of the exteriors of the building, is built of stone. The coating of the area is in serious condition, with the lower part fully compromised as the coating does not exist in this room anymore. It is possible to differentiate three different layers of coating in this area: the upper, still preserved, one in the middle, approximately 1.20 m from the ground, which presented some desolate areas on the surface, observed to the hollow sound resulting from a inspection with rubber hammer in the coating, and a third layer almost nonexistent, further down the wall. The removal sample has only two of the three layers observed. Samples from area 4 (figure 4 [d]) were removed from a wall which, even in a covered environment, had large openings. The remaining coating of this area showed some cracks, dirt and moisture spots, there were large areas with loss of adhesion and erosion of the coating.

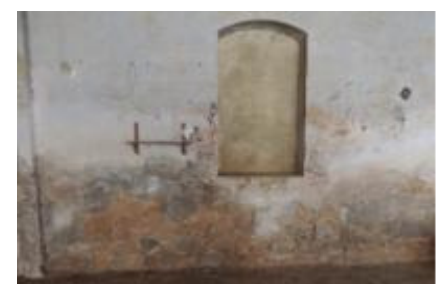
d- area 4

Figure 4.
Areas where samples were taken from the La Ceramo factory

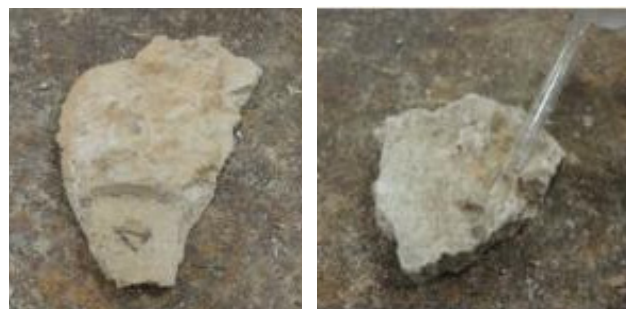
Therefore, when hydrochloric acid was applied to samples from group B (figure 5), it was possible to identify whether or not there is cement in its

Figure 5.
Test with application of hydrochloric acid in some of the samples

composition. The data found are shown in table 3. It can be observed from the results obtained in figure 5 that only the sample from area 1 presents cement in its composition, the other mortars were constituted without this component, probably containing only limestone, mineral aggregates and water.

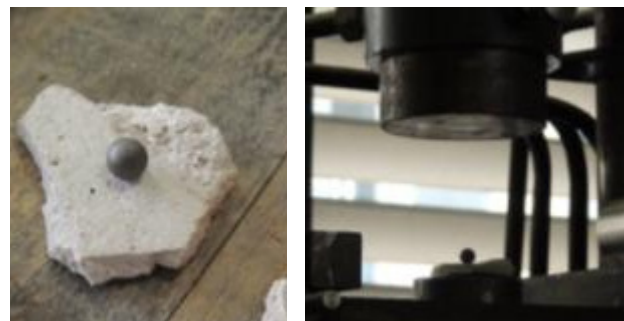
Then, the samples whose composition did not contain cement, that is, lime mortars, passed the UNE EN 13279-2 (2014) hardness test. In them, a steel sphere of diameter equal to 10 mm was placed at a fixed point on the surface, and a force of 200 N was applied, as shown in figure 6.

Figure 6.
Hardness test in laboratory

The hardness formula: $H = F / (\pi \cdot D \cdot t)$ was applied, where t refers to the depth of the mark that the sphere leaves on the surface after the test. Therefore, the hardness found in lime mortars is shown in table 7.

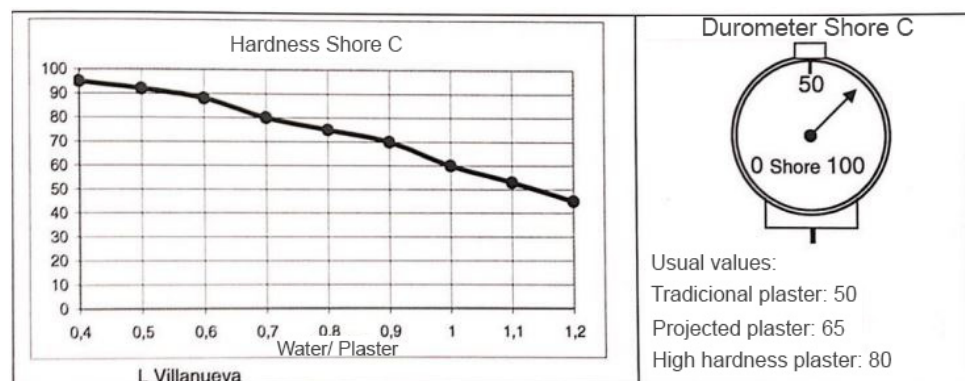
According to the graph of figure 7, the results point to hardness values between 70 and 85 Shore C, so its water to gypsum ratio is approximately 0,7.

According to the measurement conversions data of the used durometers, the measurements made with Shore C between 70 and 77 correspond to measurements performed with Shore D between 46 and 58, so measurements taken in situ and in the laboratory coincide.

Figure 7.
Shore C hardness graph.
Source: Pastor e Agórriz (2009)

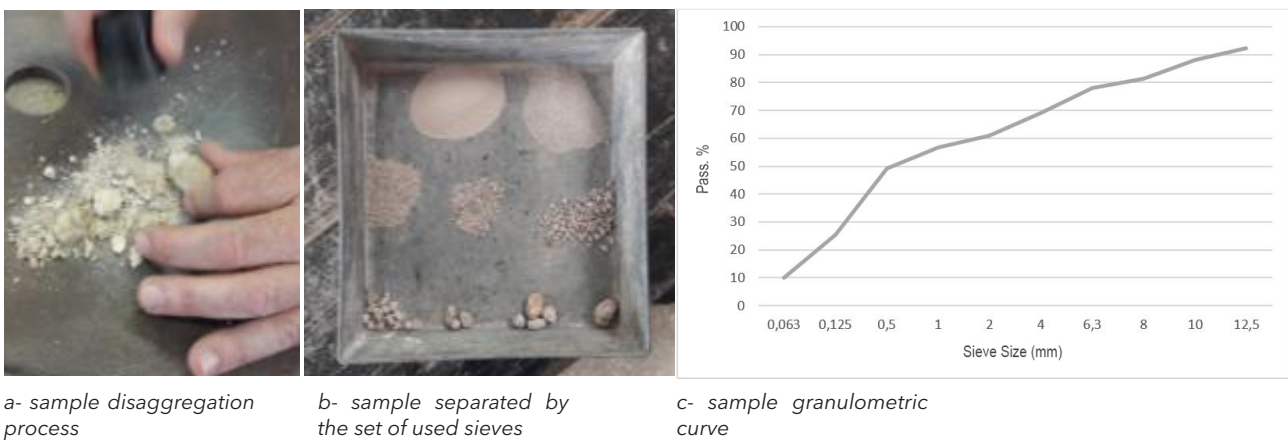
The aggregates granulometry directly influences the composition of the new mortar, in the texture, color, compactness and in the main properties of the mechanical resistances, besides the workability and water retention. The granulometry test was performed only on a sample of area 1 (cement and lime mortar), that mass was 45.2 g. The sample went through the disaggregation process with the rubber stopper (figure 8 [a]), to be able to pass the grains through the sieves, as shown in figure 8 [b].

The sieves used have their retention in mm of 12.5; 10; 8; 6.3; 4; 2; 1; 0.5; 0.125; 0.063. In each sieve, the retained material was weighed. The result of the process can be seen in the graph of figure 8 [c] which the different types of dimensions obtained in the sieving can be observed.

The granulometry presented boulders larger than 8 mm, which could already be considered too large for the composition of the mortar, and are not currently used. The aggregate used is considered well graded, with varying dimensions.

When analyzing the Coefficient of Uniformity $C_u = d_{60}/d_{10}$, it was obtained the value 31.7, greater than 15, referring to a non-uniform material. The Coefficient of Curvature obtained by the formula $C_c = (d_{30})^2/d_{60} \times d_{10}$ was 0.12; being fewer than 1, and refers to an open degree.

Figure 8.
Realization process of
granulometry test.

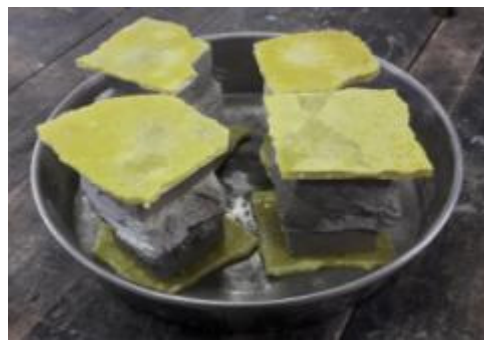
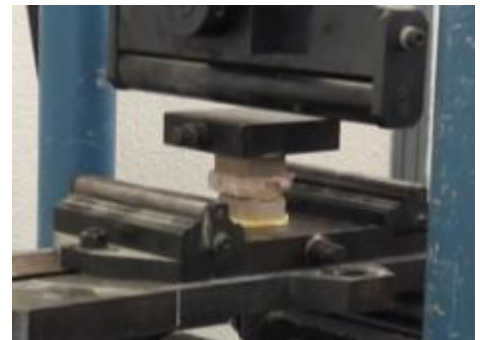
It was made wood molds of 4x4 cm to the confection of the confining mortar (composition of cement and sand in the 1:3 dash by mass) more resistant than the mortars studied, in order to regularize the surfaces of the samples and make it possible to carry out the compression test on a homogeneous basis, there are no specific accusations that will disqualify the judgment. To obtain a smooth surface, after 15 days drying of the confinement mortar, plates of sulfur were molded on them, as shown in figure 9.

Then the compression tests were performed on the four samples (1B, 2B, 3B and 4B), which had their lateral dimensions decreased, as shown in the figures in figure 9 [a]. The results are shown in the graphs in figure 10.

Figure 9.
*Test bodies and positioning
 in the compression test
 press*

a- final appearance of the tests bodies

b- test body positioned in the press

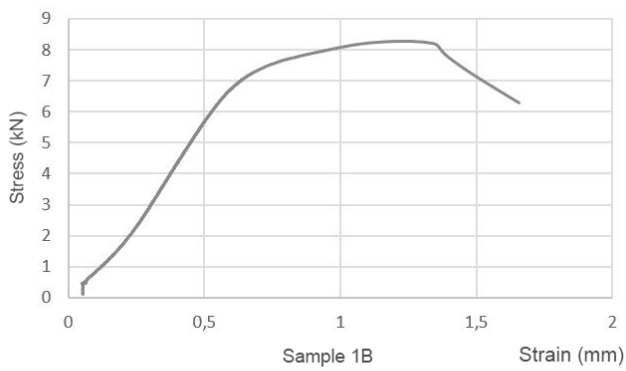
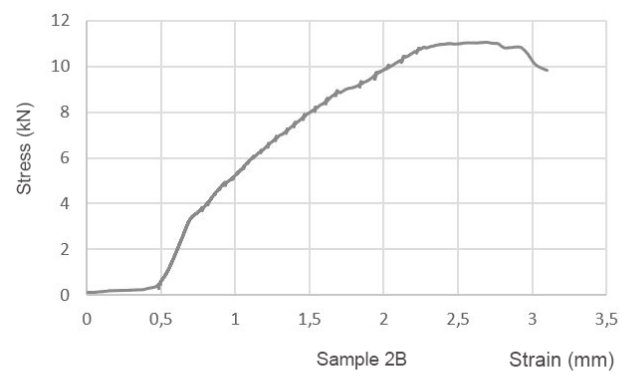
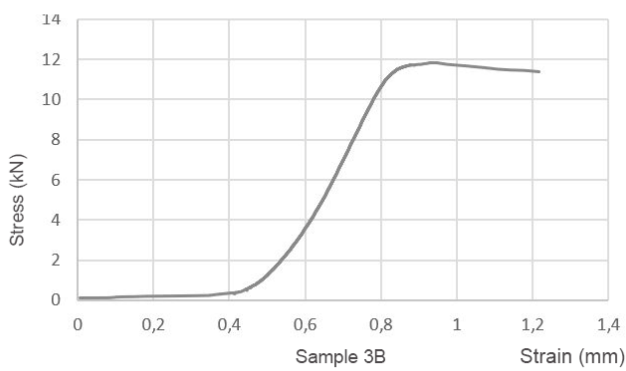
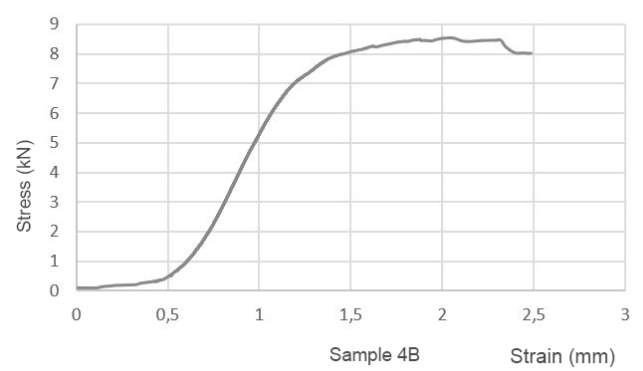
The speed of application charging with sample 1B (0.2 kN/s) was higher than the others (0.1 kN/s), because it is a mortar constituted with cement. The curvature of the graphs showed that the first two samples (1B

and 2B) are composed with more aggregates than the others (3B and 4B), because they presented a more curved graph, while the last ones, especially sample 3B, have the line formed by the graph more straight than the others, meaning a reduced amount of aggregates in their composition.

It was observed, through the values obtained in the tests, that sample 1B (cement mortar) did not present resistance to high compression, losing in mechanical resistance even for the other samples (composed only with lime), since the composite samples of lime (2B, 3B and 4B) presented slightly higher values of compressive strength.

Figure 10.
*Individual results of the compressive
 strength tests of the samples*

It should be mentioned that sample 2B could lead to a positive result in terms of compressive strength, due to the very reduced thickness of the samples in this area of study when compared to the others, but this fact cannot be considered conclusive, since the amount of regularization mortar that needed to be used was higher than the other samples, which may have influenced its final result. The high compression result of the sample 3B, however, can be taken into account, since the sample had enough thickness for a more conclusive test.

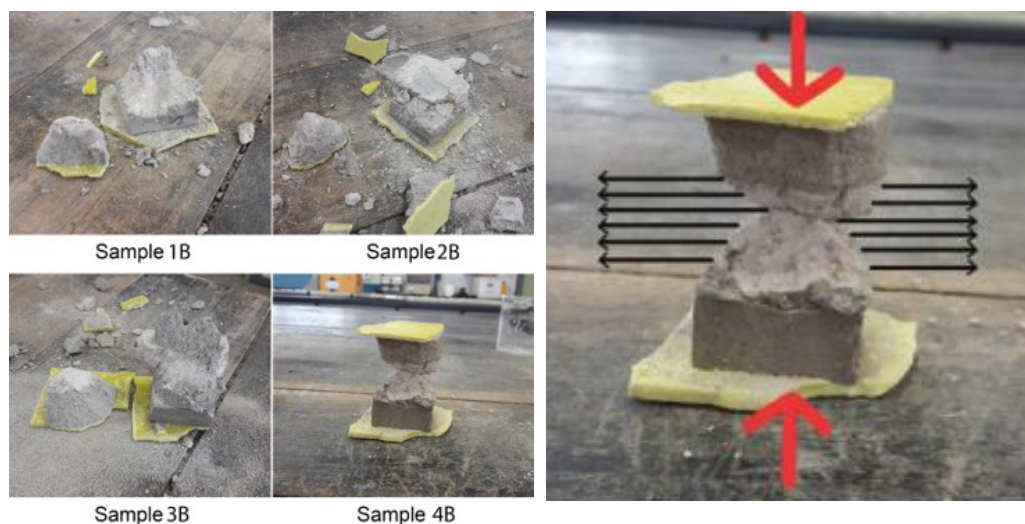
Figure 11 shows the final appearance of the samples after the compressive strength tests, and as an example, one of the samples was used to show the

vectors of forces acting on the test body during the test. The red vectors represent the compression suffered and the black ones the reaction of the part. In this way, as the upper ends were connected to another containment surface, tend to have vectors smaller than the center of the sample.

Figure 11.
Mortar samples after the compressive strength test
