# Fire Risk Assessment of Photovoltaic Plants. A Case Study Moving from two Large Fires: from Accident Investigation and Forensic Engineering to Fire Risk Assessment for Reconstruction and Permitting Purposes

Luca Fiorentini<sup>a\*</sup>, Luca Marmo<sup>b</sup>, Enrico Danzi, Vincenzo Puccia<sup>c</sup>

<sup>a</sup>Tecsa SRL, Via Figino 101, 20016 PEro (Milano), Italy

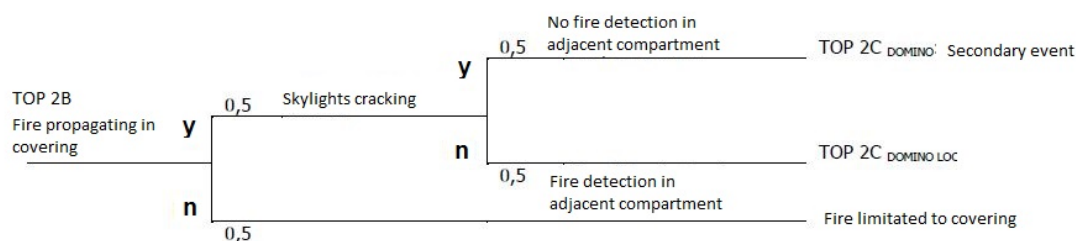
Figure 6 shows the event tree related to the Top Event defined 2C in Table 1.

*Figure 6: Event tree analysis, from fire propagating in covering to fire extended to adjacent compartment (secondary event).*

This "Top Down" fire spread scenario (from roof to underlying compartment) probably constitutes a rather new entry in fire investigation science, as produced by the interaction of a combustible insulating layer, earlier installed on the top of the building and the ignition sources inducted by the photovoltaic plant.
