Failure of cargo aileron's actuator

ABSTRACT. During a ferry flight, in a standard operation condition and at cruising level, a military cargo experienced a double hydraulic system failure due to a structural damage of the dual booster actuator. The booster actuator is the main component in mechanism of aileron's deflection. The crew was able to arrange an emergency landing thanks to the spare oil onboard: load specialists refilled the hydraulic reservoirs. Due to safety concerns and in order to prevent the possibility of other similar incidents, a technical investigation took place. The study aimed to carry out the analysis of root causes of the actuator failure. The Booster actuator is composed mainly by the piston rod and its aluminum external case (AA7049). The assembly has two bronze caps on both ends. These are fixed in position by means of two retainers. At one end of the actuator case is placed a trunnion: a cylindrical protrusion used as a pivoting point on the aircraft. The fracture was located at one end of the case, on the trunnion side, in correspondence to the cap and over the retainer. One of the two fracture surfaces was found separated to the case and with the cap

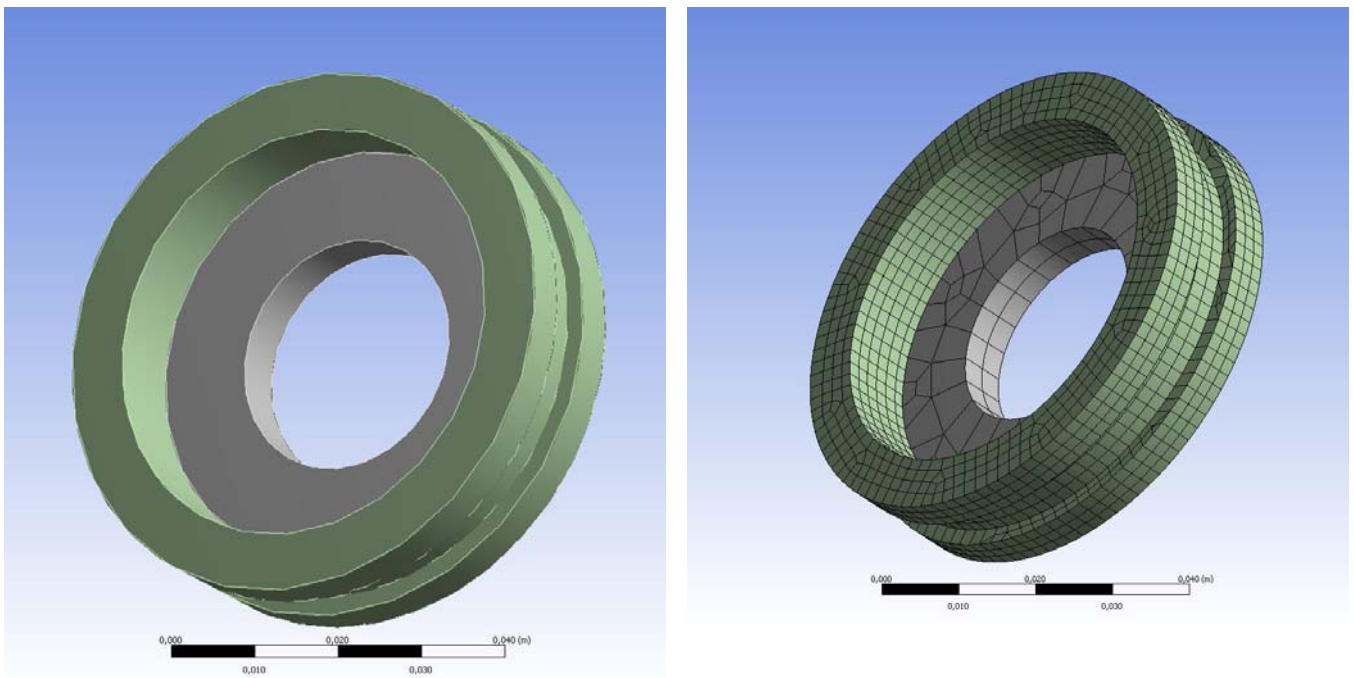
Figure 15: CAD Geometry (left), mathematical model (right).

A FEA model was performed in order to evaluate the effect of forced coupling between the actuator case and the cap. The Geometric 3D model of DBA was reproduced by the design drawings Fig. 15.

4768 hexahedrons [7] elements were applied to provide the mesh for mathematical model Fig. 15. Being impossible to reproduce exactly the geometry of the interference, it was assumed as a conservative hypothesis the perfect fit between the two parts: no gap and no interference.

The hydraulic system oil works oil within a range of 60°C - 90°C, while the pressurized cabin compartment where the DBA is placed is at about 20° C. This implies a thermal variation of $\Delta T = 40 - 70$ ° C that becomes a thermal load to the structure due to the different thermal expansion coefficient of the case assy and the cap. Indeed, the cap is made of copper alloy AMS 4631, while the case assy is AA7049. Therefore an average $\Delta T = 55$ ° C was applied.

Numerical results showed how just the perfect fit was enough to increase the stress value of about 60 MPa. In the real condition of forced coupling (about 25 μm interference) the stress increase would be higher. Stress map Fig. 16 shows how the maximum stress is reached on the outer edge of the case Assy. A parametrical simulation was carried out increasing the gap between the actuator case and the cap. Results showed that the stress became null at about 50 μm of gap (Fig. 17).
