## Fracture analysis of AA6061-graphite composite for the application of helicopter rotor blade

**ABSTRACT.** The main objective of the work is to study the fracture behavior of AA6061-graphite material using both experimental technique and finite element simulation by considering helicopter rotor blade as a case study. From the case study, it has been observed that the helicopter rotor blade, made of AA6061, has been failed at the threaded portion of the hole. Experimental fracture toughness is carried out using the compact tension specimens as per ASTM standard testing procedure. Modeling of compact tension specimens and the threaded portion of the bolt hole was utilized to analyze the fracture toughness using a simulation tool. From the results and the comparison, it is recommended to use AA6061-9wt% graphite material as a replacement of AA6061 in the application of main rotor blades of the helicopter.

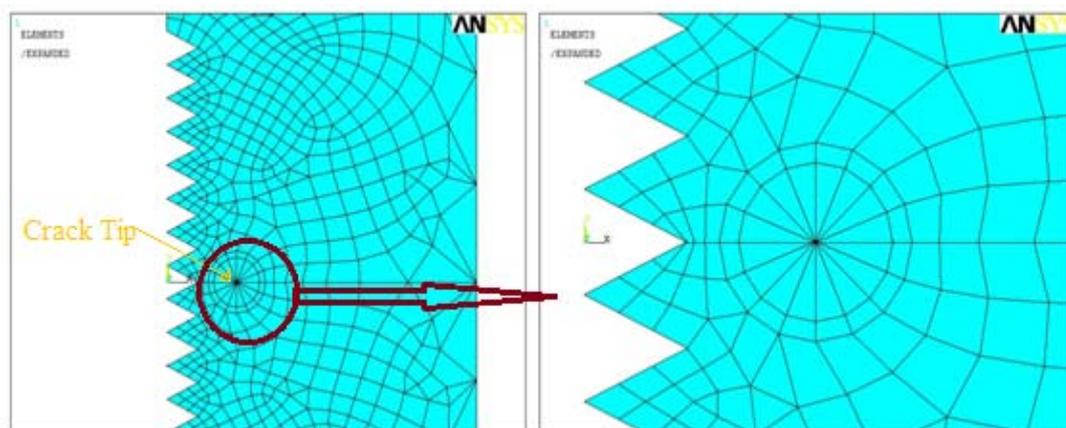
Figure 7(a) FEA Model

Figure 7(b) FEA nodes around the crack tip

The FEM model to find the fracture toughness is created using ANSYS. A structural model was created using an 8-node PLANE182 element with no real constants values. For the element PLANE182, the area has been created with a concentrated key point at the crack tip. The model was meshed, gave symmetric boundary conditions and loads applied before solving the problem. The finite element model is built using PLANE182 elements, crack tip and nodes around the crack tip are shown in Fig 7.

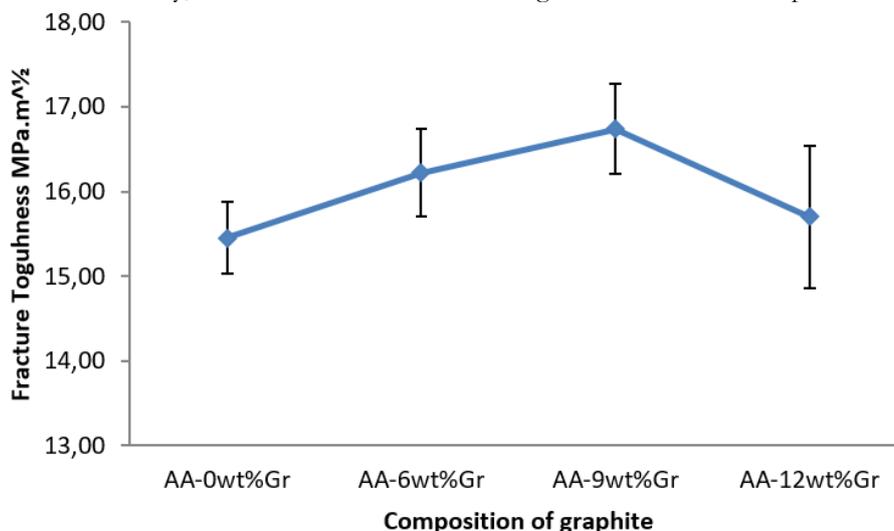
The experimental fracture toughness of the AA6061-graphite composites has been carried out for the different weight fractions of the graphite. For each composition, three CT specimens were prepared and tested. The mean value of the fracture toughness has been listed in the Tab.2. The fracture toughness with increment in the graphite percentage has been plotted as shown in the Fig 8. Specimens of unreinforced Al6061 exhibits the lesser deviations for the samples tested. However, the samples AA6061-6wt% and 9wt%graphite shows the similar deviation whereas the AA6061-12wt%graphite have the increased deviation than others. This larger deviation is may be due to the difference in the fracture toughness values among the specimens tested. Also as the graphite composition increases the fracture toughness increases up to 9wt% of graphite and later decreases at 12wt% of graphite. This decrement is due the increase of reinforcement decreases the ductility, thus decreases the fracture toughness of the said composite.

Figure 8: Fracture toughness of the AA6061-graphite composites.
