Integrated Approach in Geophysical Investigation of Road Failure in Crystalline Basement Environment in South-western Part of Nigeria.

Olabanji Ojo^{1*}, Victor Adejumo², Obaromi Olubunmi²

¹Department of Geological Sciences, Osun State University, Osogbo, Osun State, Nigeria.

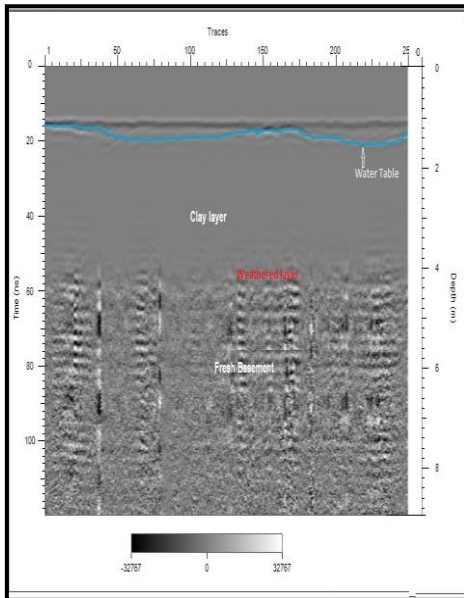
Fig 6: GPR Profile Traverse 3Fig

This result is similar to that obtained using the dipole-dipole technique. The material that constitute the overburden is rich in clay and varies in thickness from about 4 – 5 meters. The depth to the water level also varies from 1.40 meters in Figure 4 to 2.0 m in Figure 5. This result is also confirmed in the dipole-dipole that was run in the area which reveals the depth of 4.5 to 5 meters to the incompetent less resistive layer having resistivity values of 46 and 89 Ω m in Figure 4 and resistivity values of 14 and 171 Ω m in Figure 5. This observation is also obtained in Figures 6 to 15.

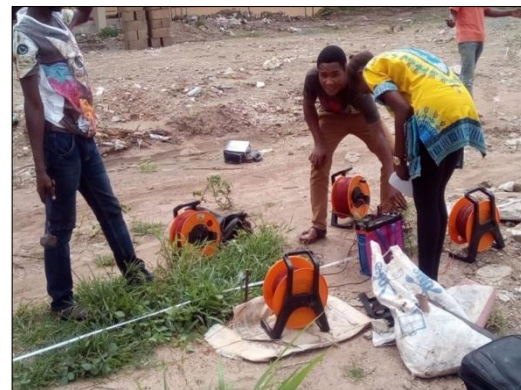
Figure 17: Picture showing ongoing dipole-dipole geophysical survey on the failed portion of the road
