## Green Maintenance for Heritage Buildings: Low Carbon Laterite Stones Repair Appraisal

Brit Anak Kayan, Imaduddin Abdul Halim, Nurush Syhadah Mahmud\*

Centre of Building, Construction and Tropical Architecture, Faculty of Built Environment, University of Malaya (UM), 50603 Kuala Lumpur, Malaysia  
[nurushsyhadah@um.edu.my](mailto:nurushsyhadah@um.edu.my)

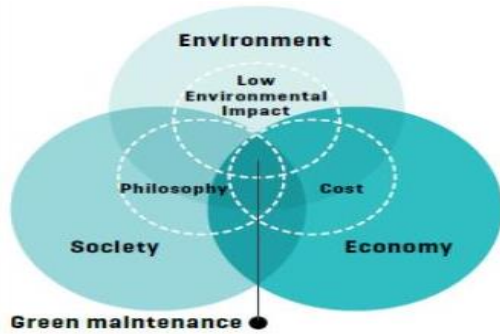
Figure 1: 'Green Maintenance' concept (Kayan, 2013)

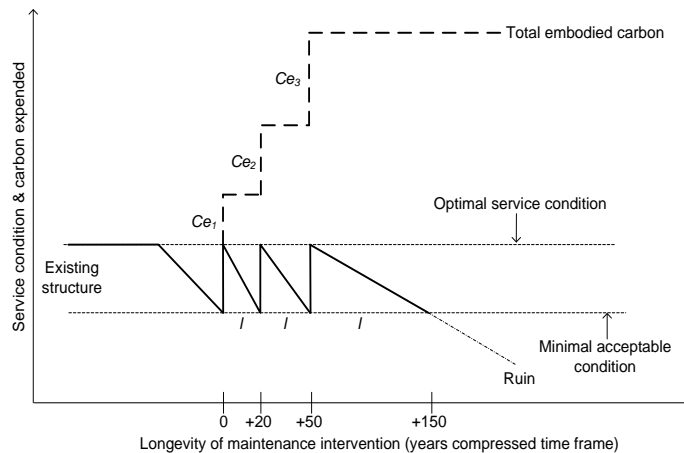
Figure 2: Relationship between longevity of repair and embodied carbon expenditure (Forster et al., 2011)

'Green Maintenance' put the priorities on low carbon material and repair techniques (either single or combination) selection during maintenance period based on the measurement of CO<sub>2</sub> emissions. The measurement of CO<sub>2</sub> emissions would cover the extraction of raw materials to the end of the product's lifetime (cradle-to-grave) of LCA boundaries, but in acquiring accurate result, the measurement is limited to cradle-to-site analysis (raw material extraction and processing, transportation, manufacturing, and transportation to the building site). 'Green Maintenance' sets out an insight on the relationship between maintenance and repair, and CO<sub>2</sub> emissions in selecting the low carbon repair for heritage buildings. Figure 2 shows the proposition of relationship between each intervention and CO<sub>2</sub> emissions characterised by its longevity (l) and embodied carbon expenditure (Ce) on the service graph condition. The downward sloping signifies the declining condition of the buildings over the life cycle of repair. Each intervention is important to keep the buildings at the optimal service condition, but it contributes to CO<sub>2</sub> emissions. Hypothetically, the more frequent the maintenance intervention, the greater the embodied carbon expended (Forster et al., 2011).

'Green Maintenance' gives higher preference to the repair technique that has high longevity which subsequently incurred lesser number of repeating interventions and may incur lesser embodied carbon expenditure over the life span of the building. There will be a single or combination of repair techniques in a certain maintenance period in practical. High consideration on numbers, type of repair, and the embodied energy and CO<sub>2</sub> expended in repairs are therefore paramount important in this evaluation. Every intervention is also influenced by other variables including material durability, degree of exposure, building detailing, quality of repair, and specification. The generated Total EMI (Eq(1)) is the product of area repaired (in this case is wall surface), material used in tonnage (t), and their respective Embodied Carbon Coefficient (ECC) added to the product of material used (t), CO<sub>2</sub> emission factor, and resourcing location (km) for respective frequency of repair (n) within hundred-year arbitrary period.
