## What Do Gas Blows, Iron Dust Accumulations and Sulfidation Corrosion Have in Common?

This paper presents an analysis of three process incidents recently investigated by the US Chemical Safety Board (CSB): (i) Kleen Energy natural gas explosion (Middletown, CT), (ii) Hoeganaes Corporation iron dust flash fires and hydrogen explosion (Gallatin, TN), and (iii) Chevron Richmond refinery pipe rupture and fire (Richmond, CA). The starting point for the analysis is identification of the main hazardous materials, activities or conditions underlying the specific incident losses. These are, respectively: (i) Kleen Energy – purging of process pipelines with natural gas, (ii) Hoeganaes Corporation – accumulations of combustible iron dust in work areas, and (iii) Chevron Richmond refinery – a pipeline damage mechanism known as sulfidation corrosion. While the three incidents have many aspects in common, chief among the similarities are the key process safety concepts of inherently safer design (ISD), recognition of warning signs (precursor events), and safety culture. Each incident is analyzed for evidence of these concepts.

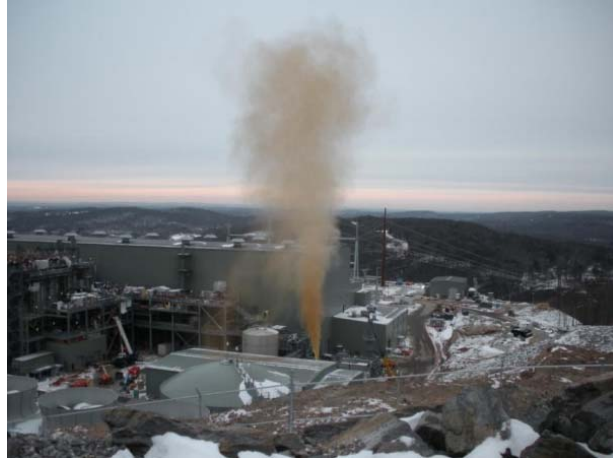
Figure 1 shows a *gas blow* (used to remove pipeline debris) at the Kleen Energy power plant in Middletown, CT one week before repeated application of this procedure lead to an explosion that killed six workers. The fuel for the explosion was natural gas being forced through a pipe at a pressure of 4.5 MPa and eventually exiting into a congested, outdoor work area where a number of potential ignition sources existed (CSB, 2010).

Figure 1: Cleaning of fuel gas piping by gas blow at Kleen Energy site one week before incident (CSB, 2010).

The CSB recommendations (CSB, 2010) arising from the Kleen Energy explosion well-address these basic features of inherent safety. There is clear evidence of use of the hierarchy of controls in these recommendations which incorporate first, elimination of the fire and explosion hazard by prohibiting the release of flammable gas to the atmosphere for the purpose of cleaning fuel gas piping, through to the use of combustible gas monitoring, and the development of flammable gas safety procedures and training. One specific recommendation invokes the inherent safety principle of substitution in the case of replacing natural gas with a less hazardous gas, such as air, in the cleaning of fuel gas piping. The principle of simplification is also relevant here in helping to ease the complex requirements for discharge design when using natural gas for pipeline cleaning. CSB (2010) also addresses the issue of whether alternative cleaning methods are technically feasible by commenting that safer alternatives, such as air, are just as effective as natural gas for cleaning fuel gas piping.

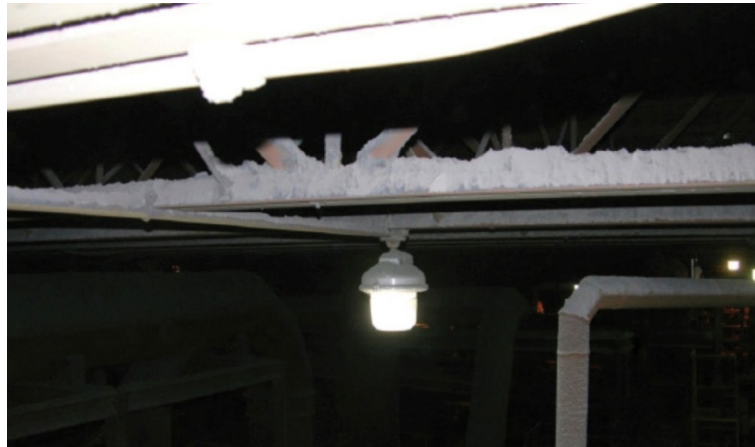
Figure 2 shows overhead *iron dust accumulations* at the Hoeganaes facility in Gallatin, TN, which manufactured iron powder for the production of metal parts in the automotive and other industries. Combustible iron dust deposits in this workplace helped fuel three separate incidents: (i) an iron dust flash fire that killed two workers, (ii) another iron dust flash fire that injured one employee, and (iii) a hydrogen explosion resulting in multiple iron dust flash fires killing three workers and injuring two others (CSB, 2011).

Figure 2: Iron dust deposits on elevated surfaces at Hoeganaes Corporation facility (CSB, 2011).

In the case of the three Hoeganaes incidents, the explosion pentagon provides insight into the role of ISD in explosion prevention and mitigation. The pentagon consists of the familiar fire triangle elements of fuel, oxidant and ignition source, augmented by the need for fuel/oxidant mixing and some degree of confinement of the resulting combustible mixture. In general, confinement can be addressed by explosion relief venting (a passive engineered safety measure), oxidant by inert gas blanketing (an active engineered safety measure), and ignition sources in part by hot-work permitting (a procedural safety measure). Much more effectively, the fuel component of the explosion pentagon (i.e., iron dust accumulations) can be eliminated or minimized by ISD considerations – e.g., through the design of equipment to contain dust so that it does not escape and does not have to be cleaned up, and by facility design for easy and effective cleaning (Frank and Holcomb, 2009). A good procedural program of adequate housekeeping can also be thought of as having strong ISD overtones (Amyotte, 2013).

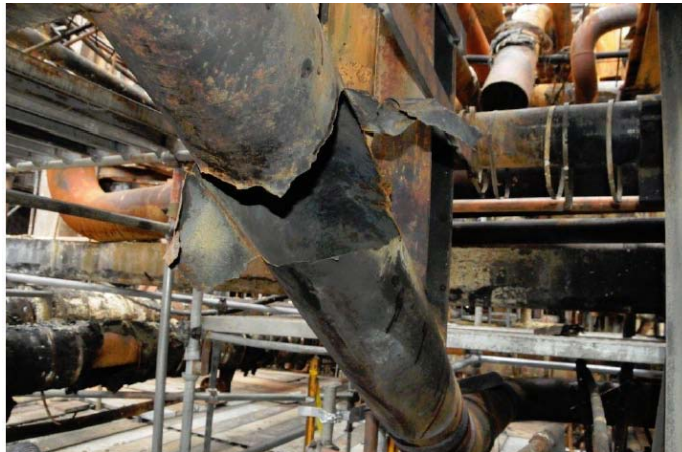
Figure 3 shows the result of *sulfidation corrosion* of a pipeline at the Chevron refinery in Richmond, CA. The pipe ruptured and a hydrocarbon vapour cloud was formed; nineteen employees in the vicinity narrowly escaped injury when the cloud ignited. The general public were less fortunate, with 15,000 nearby residents eventually seeking medical treatment due to emissions from the process fire (CSB, 2013, 2014, 2015b).

Figure 3: Pipeline degradation due to sulfidation corrosion at Chevron Richmond refinery (CSB, 2013).

CSB (2013) and CSB (2015b) dealing with the Chevron Richmond refinery incident each contain several pages of informative text on various aspects of inherently safer design. These interim and final investigation reports describe the role of inherent safety within the hierarchy of controls, as well as the facts that ISD is hazard-specific and is most easily and effectively introduced early in the process life cycle (e.g., at the design/build stage). Substitution of a higher chromium-content steel alloy (e.g., “9-Chrome”) – which is less susceptible to sulfidation corrosion than the low-silicon carbon steel in place – is arguably the most significant missed ISD opportunity in this case.
